Washouts, Bottlenecks Slow Race Flow

MAP OF MILLRACE: BEGINNING TO END

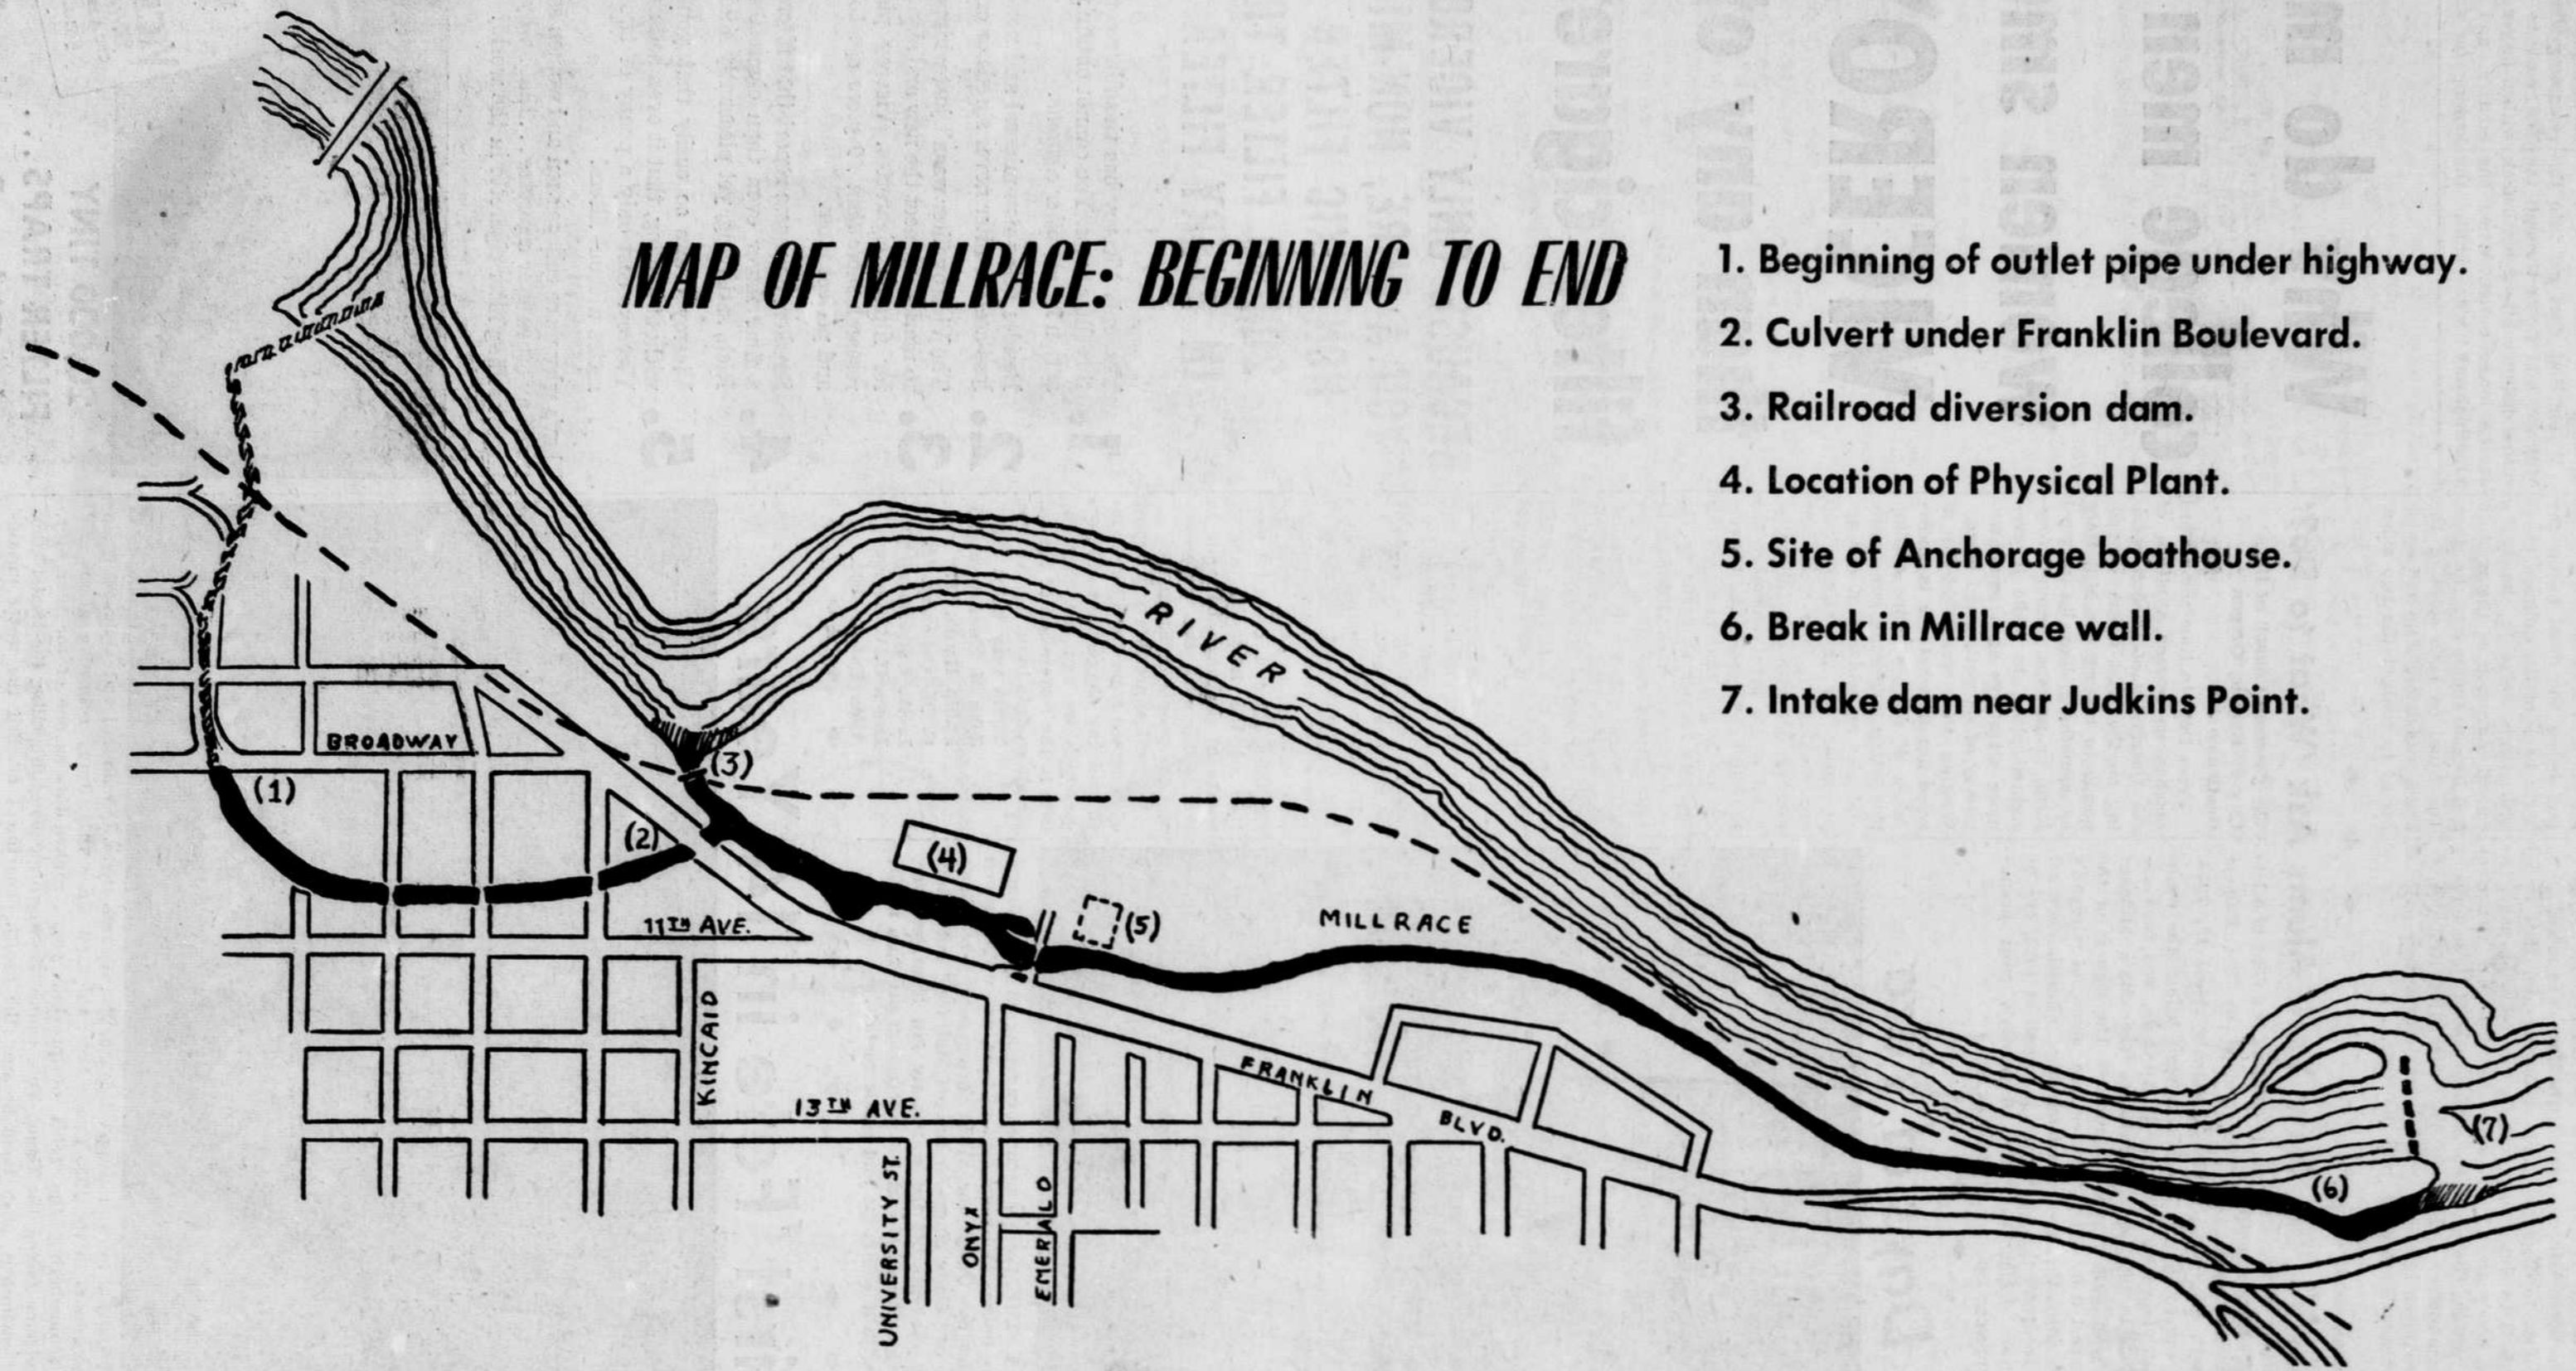
1. Beginning of outlet pipe under highway.
2. Culvert under Franklin Boulevard.
3. Railroad diversion dam.
4. Location of Physical Plant.
5. Site of Anchorage boathouse.
6. Break in Millrace wall.
7. Intake dam near Judkins Point.

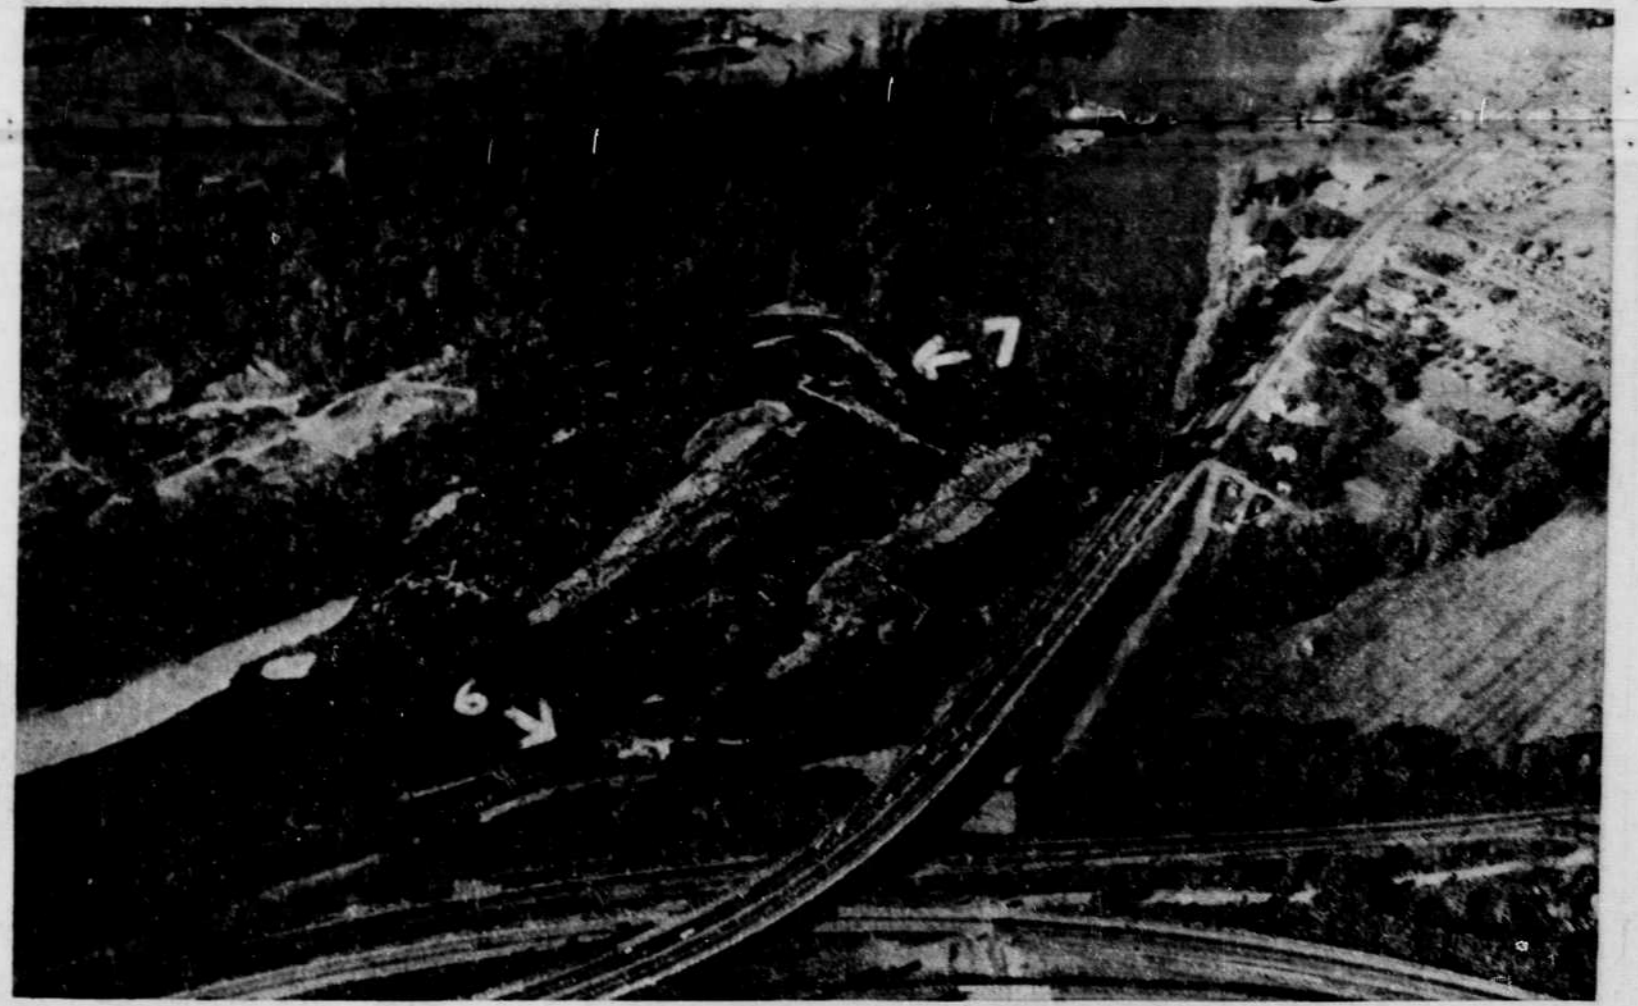
7 – The Dam Ain't Long Enough

THIS AERIAL PHOTO shows clearly two of the problems faced in restoration of the millrace. Arrow 7 points to the dam, showing how the river has washed around the north end. The city attempted to stop this bad flow by dumping rock and gravel from the north bank out to the dam. This did not stop the washing out, however, and now the river has gouged a large hole out of the north bank of the river, carrying away almost three acres

of city owned land. In addition to washing out the north bank, this current is directed to the south bank, where it is undermining the unprotected bank of the Millrace. Arrow 6 points to the break in the millrace canal which occurred in the 1940's. The canal was dammed up on both sides of the break, and a pipe carries the water from one side to the other.

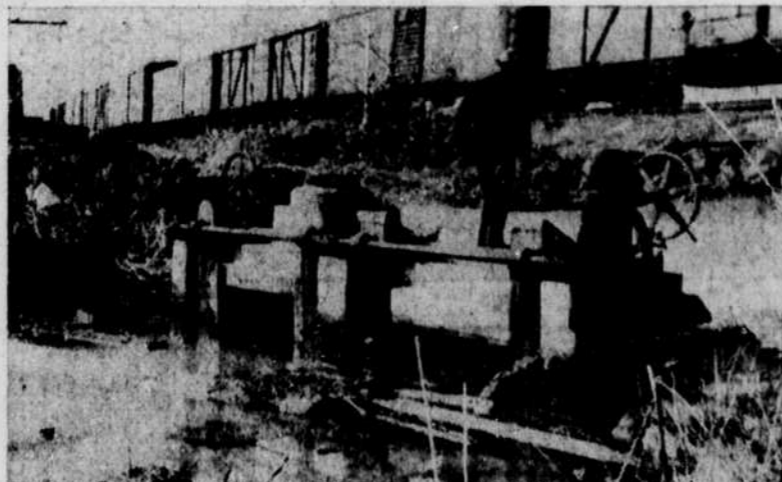
3 – The Outlet?

THIS DAM WHICH ALLOWS water to overflow the race into a channel which heads to the river, could be re-built, in order to provide for a much greater flow out of the millrace. Since engineers do not consider the outlet pictured at the left to be adequate if the flow would be greatly increased, this site would probably be used to get the water out of the millrace. Although it would not increase the flow past the Millrace houses, it would nevertheless provide a sanitary flow.

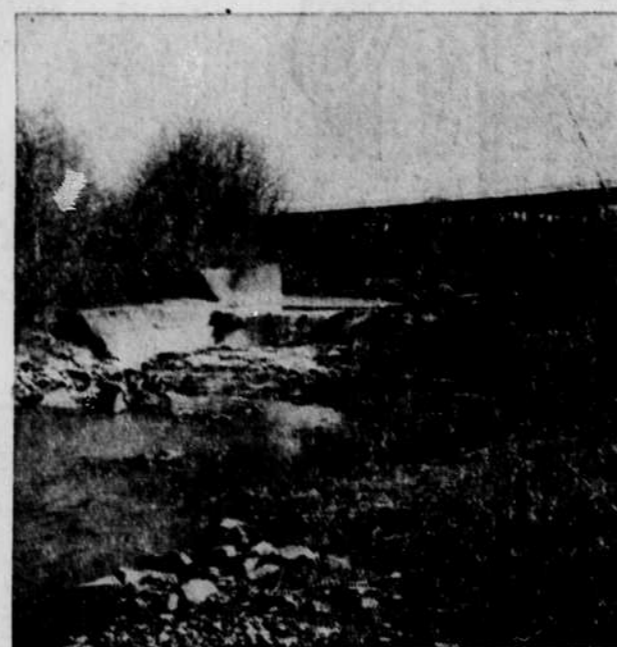
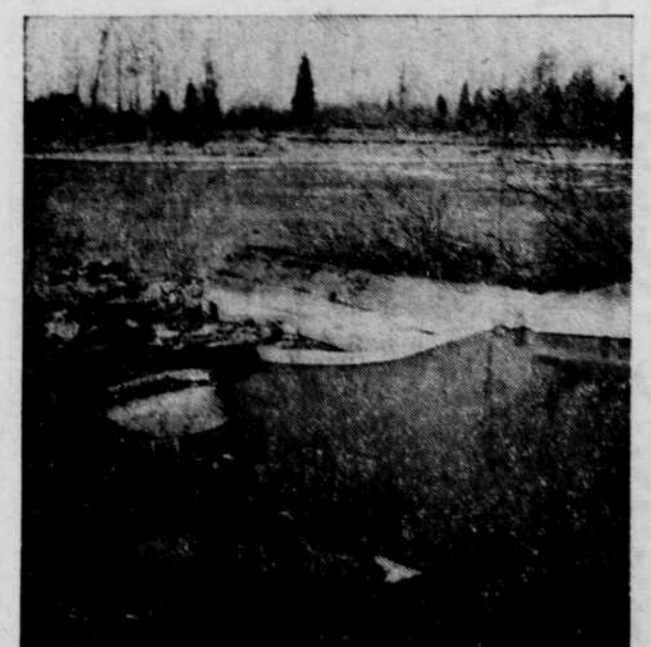
6 – The Bottleneck; Fore and Aft

THE TWO PICTURES ABOVE are different shots of the same site. The photo on the left gives a view of the washout from downstream; the right photo gives the upstream view. When the wall was washed out in the 1940's, the 'Race' was dammed up on both sides of the break, and an underground pipe was installed to

carry water from one side of the break to the other. The grill in the lower left hand corner of the right picture shows where the water enters the pipe. This pipe controls the flow of the millrace, since all millrace water must pass through it.
