PUBLIC WORKS CHIT-CHAT !!!

Gary Shipley, Public Works Superintendent

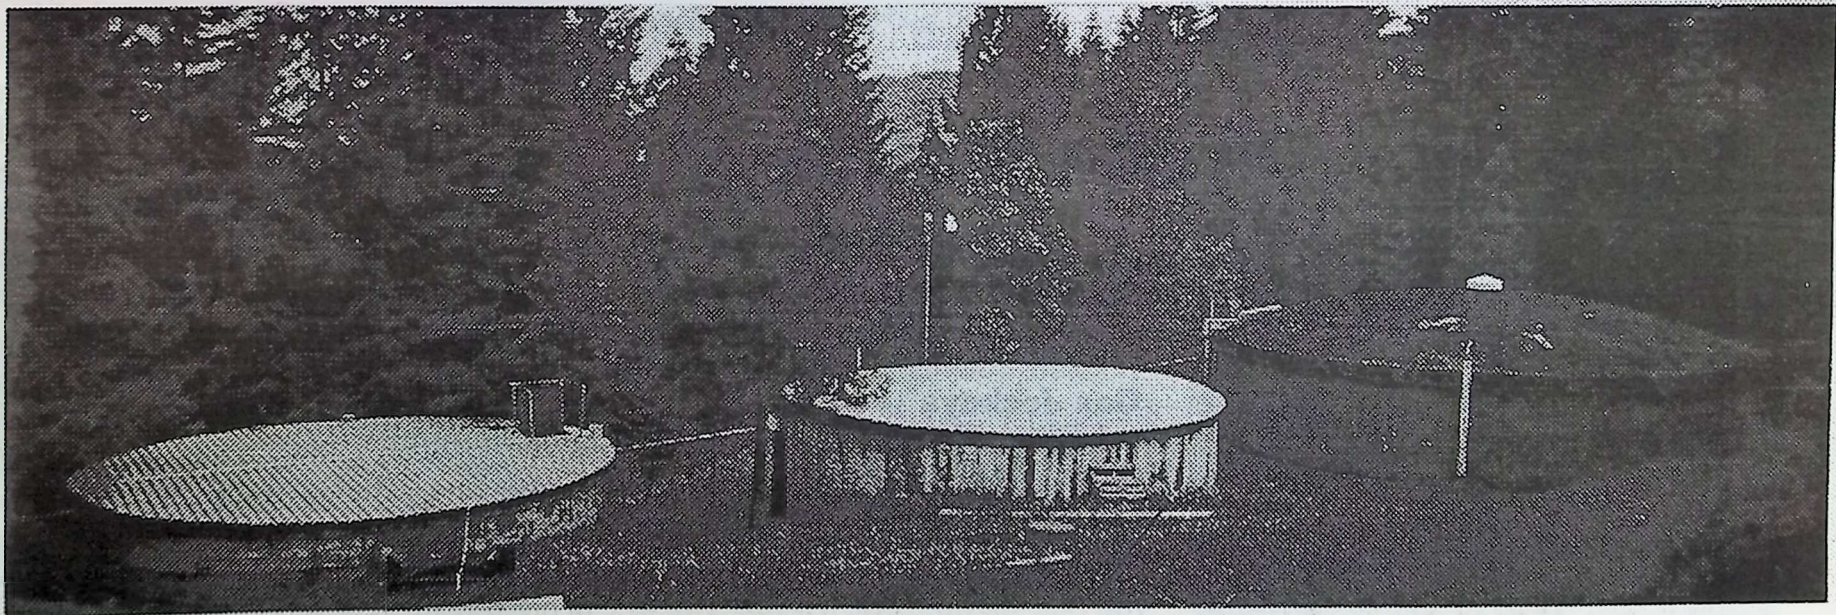
The original water reservoir built in 1912 is finished with the maintenance and renovation work to stop approximately 100 gallons per minute from leaking. Now we are faced with repairs on the newest tank. The concrete lid is deteriorating, and is in need of immediate attention. This project, hopefully, will not require the draining of the tank.

WATER FLOWS INTO THESE THREE RESERVOIRS from Ginger Springs one-half mile to the south. The total capacity of these reservoirs is about 270,000 gallons. The reservoir on the left, with a capacity of nearly 36,000 gallons, was built in 1912 and was recently sealed and relined, due to leaks, at a cost of almost \$4,000. The center tank was constructed in 1947 and has a capacity of 54,150 gallons. The right reservoir, constructed in 1973, is a steel walled/concrete lined tank with a capacity of 180, 850 gallons. Due to lack of maintenance, the moss growing on its roof (dark color) has caused the concrete to deteriorate. Before major damage occurs this will need to be repaired at an estimated cost of \$6-8,000.
