# Emigrant Dam Is Constructed on Scientific Principals

## Material Is Not Loose Dirt, Rock, Engineers Report

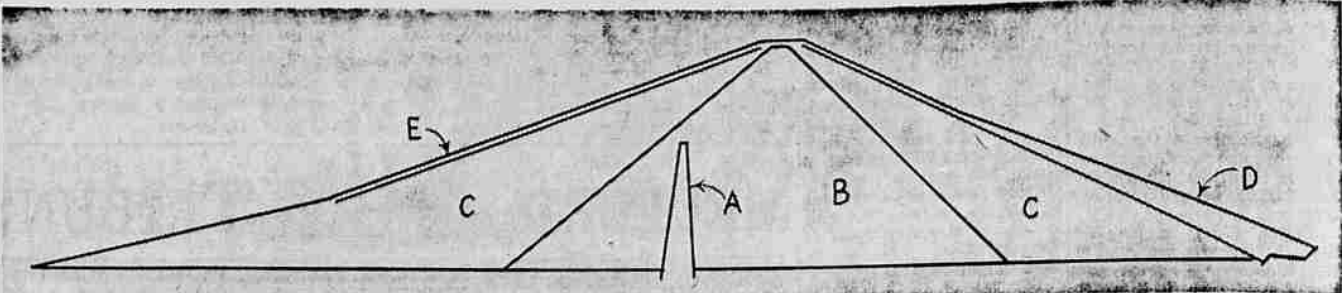
**DIMENSIONS SHOWN** — The schematic diagram of a cross-section of Emigrant dam, adapted from engineering plans for the structure, show its "profile" and dimensions. The width at the base is approximately 1,100 feet, and at the top, about 35 feet. Total height is 190 feet. The old concrete dam (A), which is an integral part of the new structure although buried by the earth, clay and rock of the new one, is 110 feet high. Sections marked B

are of highly compacted clay-type earth, packed down inch by inch, with sheep-foot rollers. Sections marked C are compacted sand, gravel and cobbles. Section D is rock and E is rip-rap over rock and gravel. Width of the compacted earth section is 470 feet at the base, and the rock sections are each some 300 feet thick. At maximum pool, surface of Emigrant lake will be 12 feet below the top of the dam.

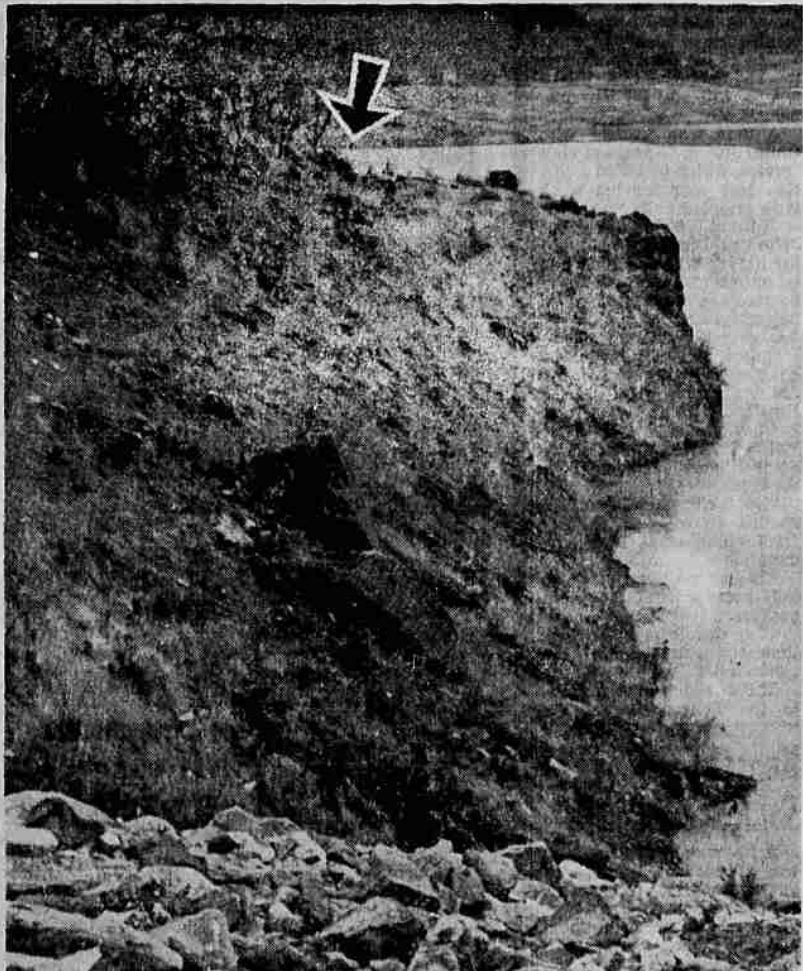
The outcrop of concern to Tucker (see photos) is some 200 or more feet from the dam itself, and is one of a number noted in early geological surveys of the area.

**SLIDING OUTCROP** — One of the fears expressed concerning Emigrant dam last week by E. M. Tucker Sr., of the Tucker Sno-Cat Corp., concerned a sandstone outcrop several hundred feet from the dam on the east side. It is shown jutting into the water in picture above, and arrow points to the "crevasses" Tucker has mentioned. He fears that the weight of the dam and the

lake are responsible. However, bureau of reclamation engineers say the outcrop was undercut by action of rising and falling water on soft formation beneath it. They say it probably will drop into the lake eventually, but if it did, no harm would result. Picture was taken from crest of dam, which shows in foreground.

ed and watched for years by irrigation district personnel, and by bureau engineers and geologists. It was marked, measured, and studied for movement for a long period. The conclusion was that the rising and falling action of the water from season to season, coupled with the wetting and drying action, had eroded and undercut soft formations below the outcrop, causing it to tip out.

It probably will fall into the lake some day, the bureau men believe, but this would cause no harm to the dam itself.

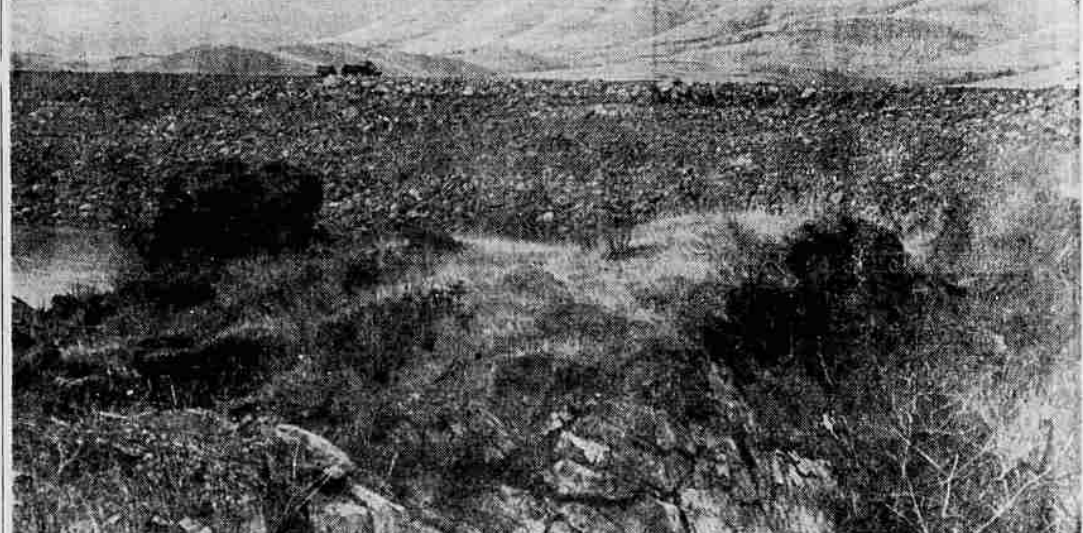
**'CREVASS' SHOWN** — The slowly widening gap between a sandstone outcrop and the side of the hill, mentioned by Tucker, is shown above. Dam is several hundred feet away in background; lake water can be seen at left. One of the

cracks or crevasses can be seen at right of picture. It was measured at 20 feet deep, but may have been deeper before loose dirt fell into it.
