Pauling Center workmanship questioned

Story by David J. Hayden
and Duffy Coffman
Of The Print

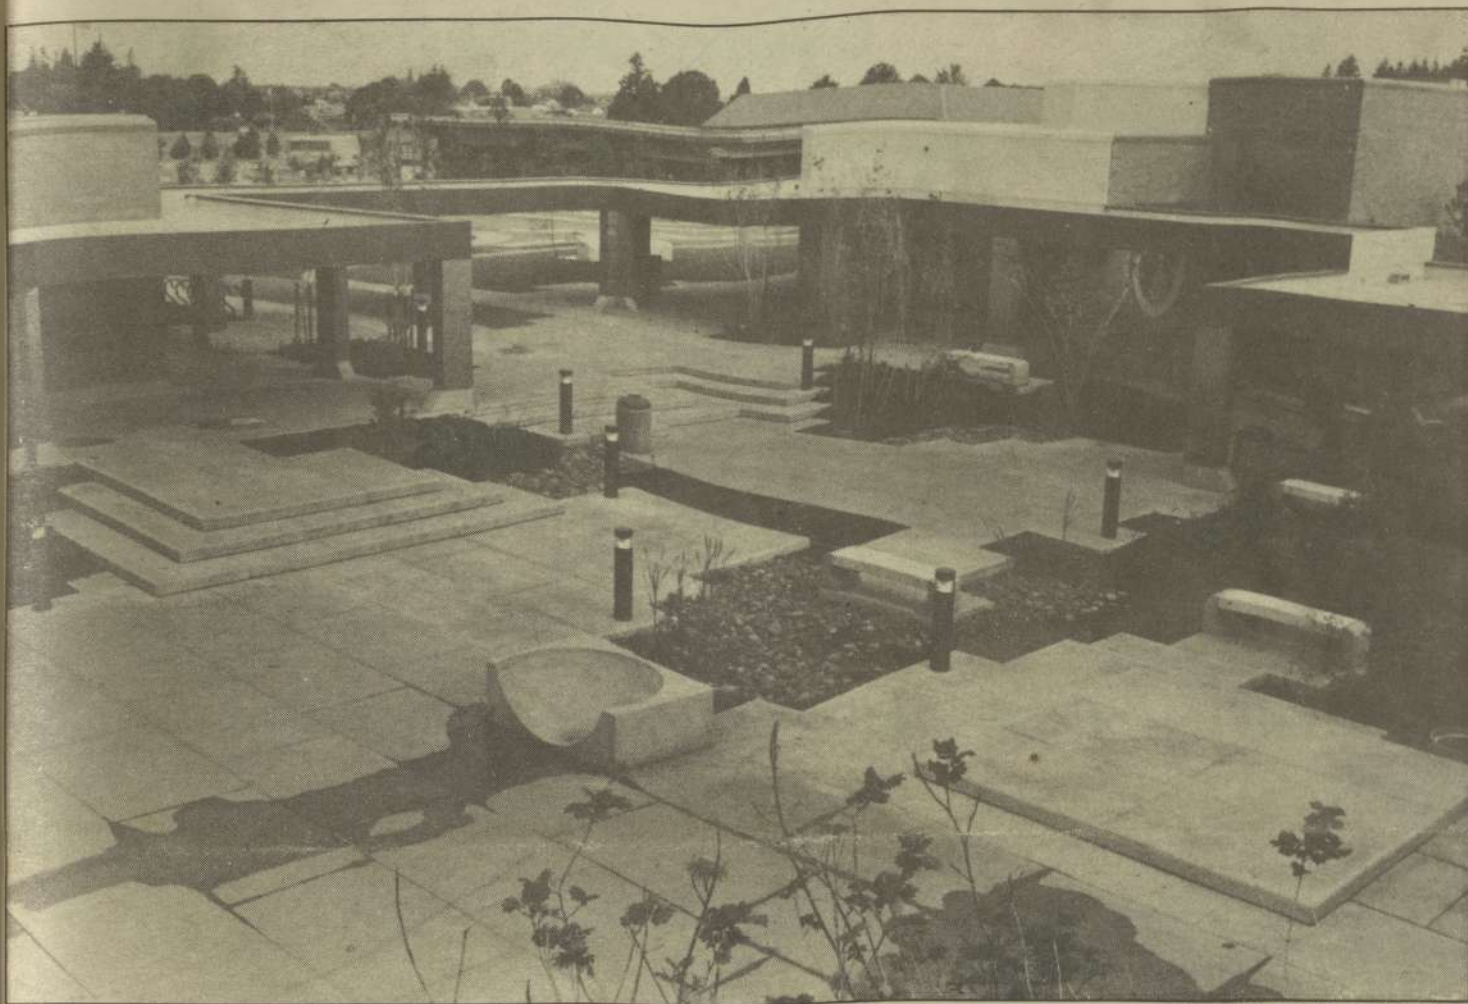
CENTER OF ATTENTION—The newly constructed Pauling Science Center has yet to be accepted because of various problems in the construction. The problems have ranged from cracks in the courtyard to inferior plants being used in the landscaping.
