## Pictorial Review of the Progress of the Ochoco Irrigation Dam and Canal System

### Pictures Taken From Time to Time in the Course of Its Construction

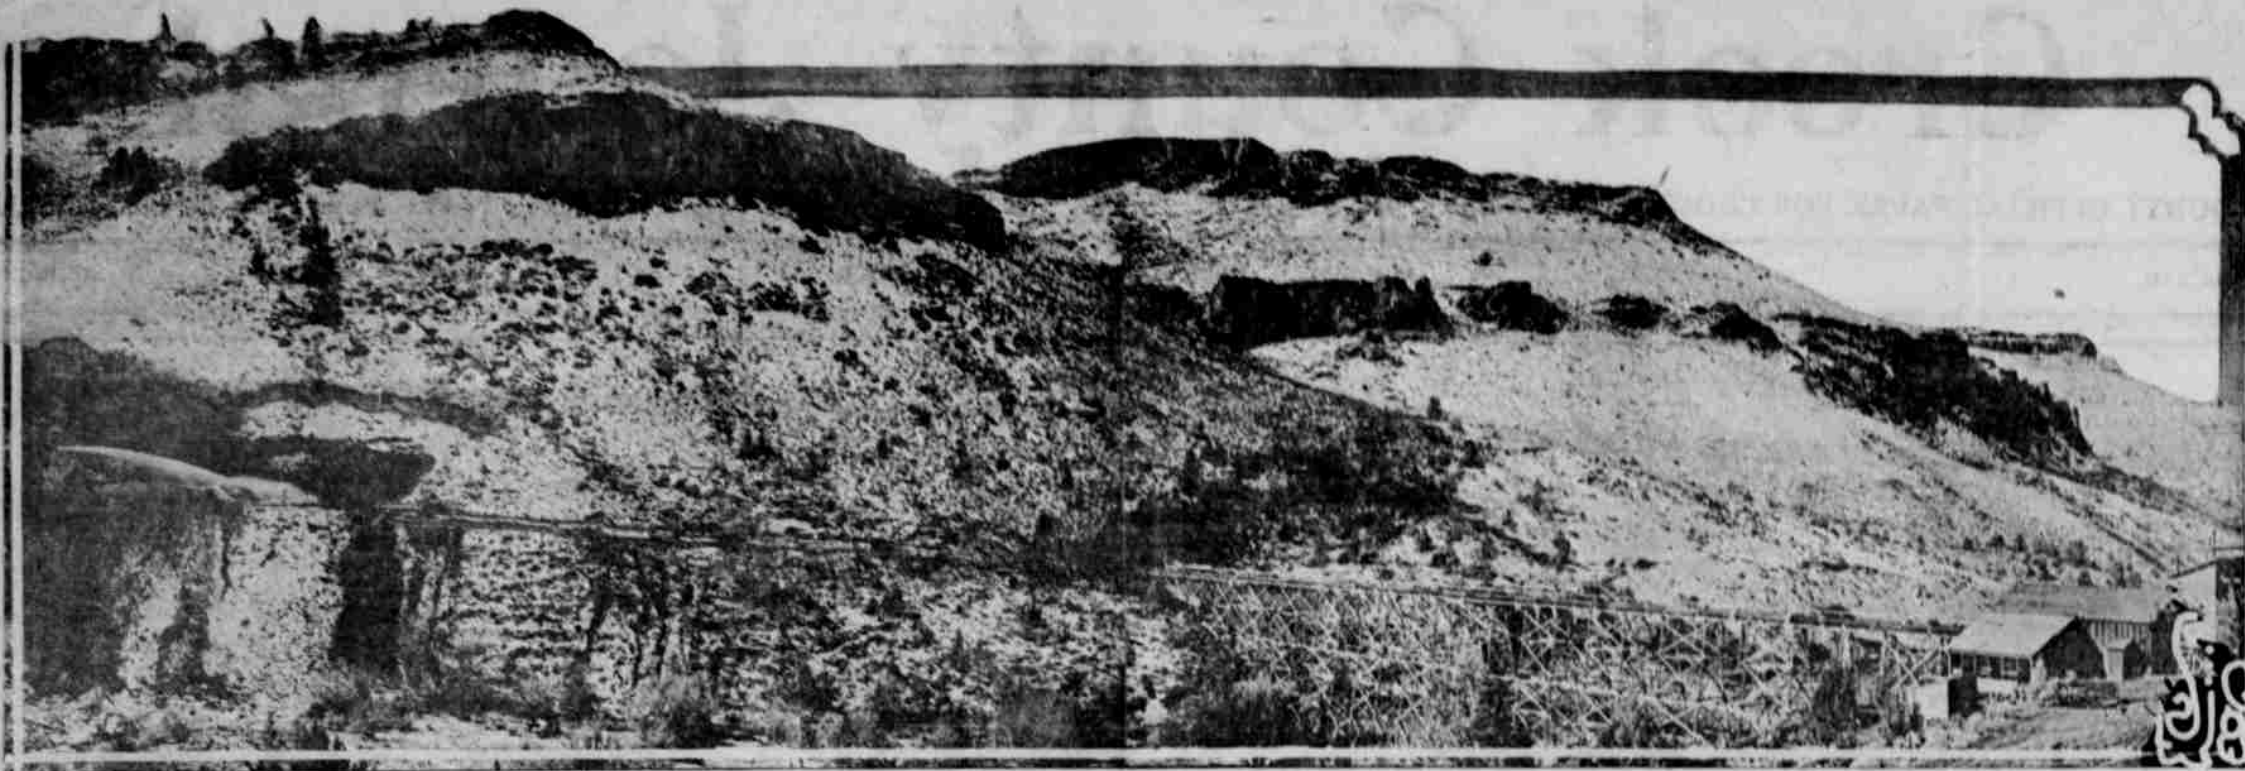
The photograph at the top of the page shows the south side of the valley, and was taken early in the winter.

The material supply shown in this picture was well tested, and seemed to be ample for the construction of the entire dam, but after work was started it proved difficult to work, and after a number of different pits were opened up here, the entire effort on the south side of the stream was abandoned, after the small dam was completed, and the giants were moved to the north side of the river, and will start there early in August.

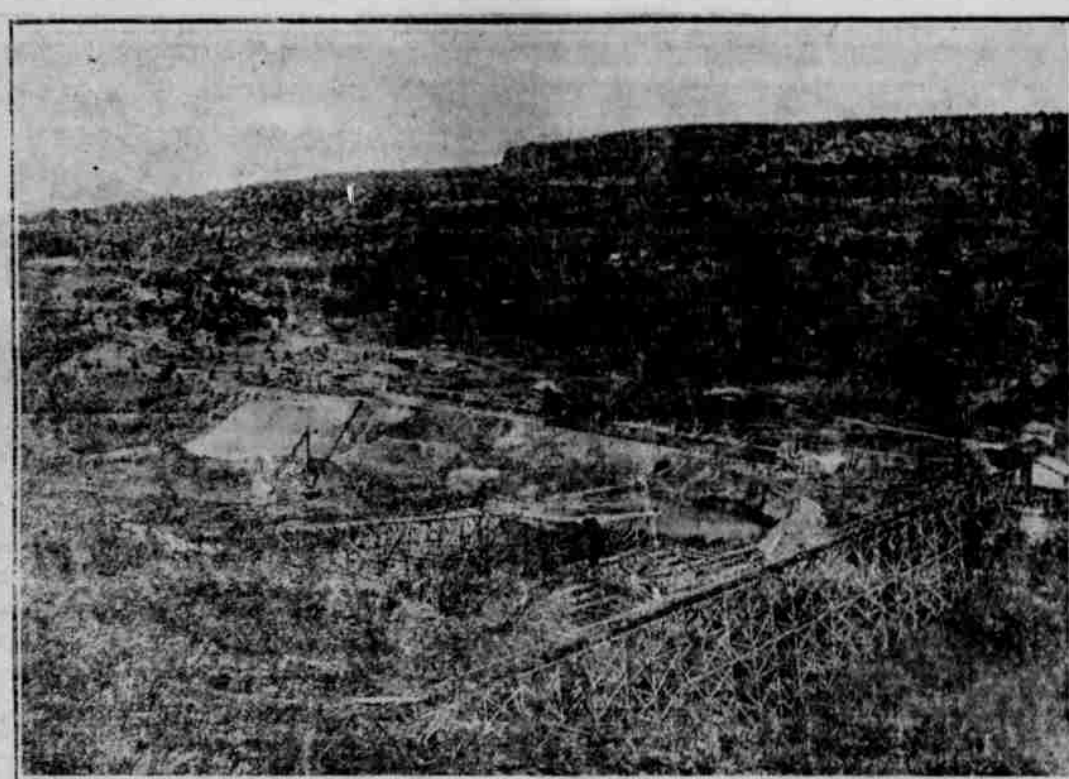
The picture in the center of this page shows a close up view of the site for the dam, looking from the south to the north side, and will give more of an idea of the up and down stream dimensions of the dam.

In the foreground is a trestle which was used to convey the immense pipe line across the river for the giants, and below is the upper toe of the dam, which was at that time being constructed.

In the left center of this picture is the "clam shell" or "stiff legs" hoist, which at the time the picture was taken, was being used to make a cut off or key trench in the bottom of the dam proper.

A much smaller trench of the same kind was dug under the small dam, or the upper toe, which serves as a double insurance against the immense pressure that will result when the reservoir is filled with water.

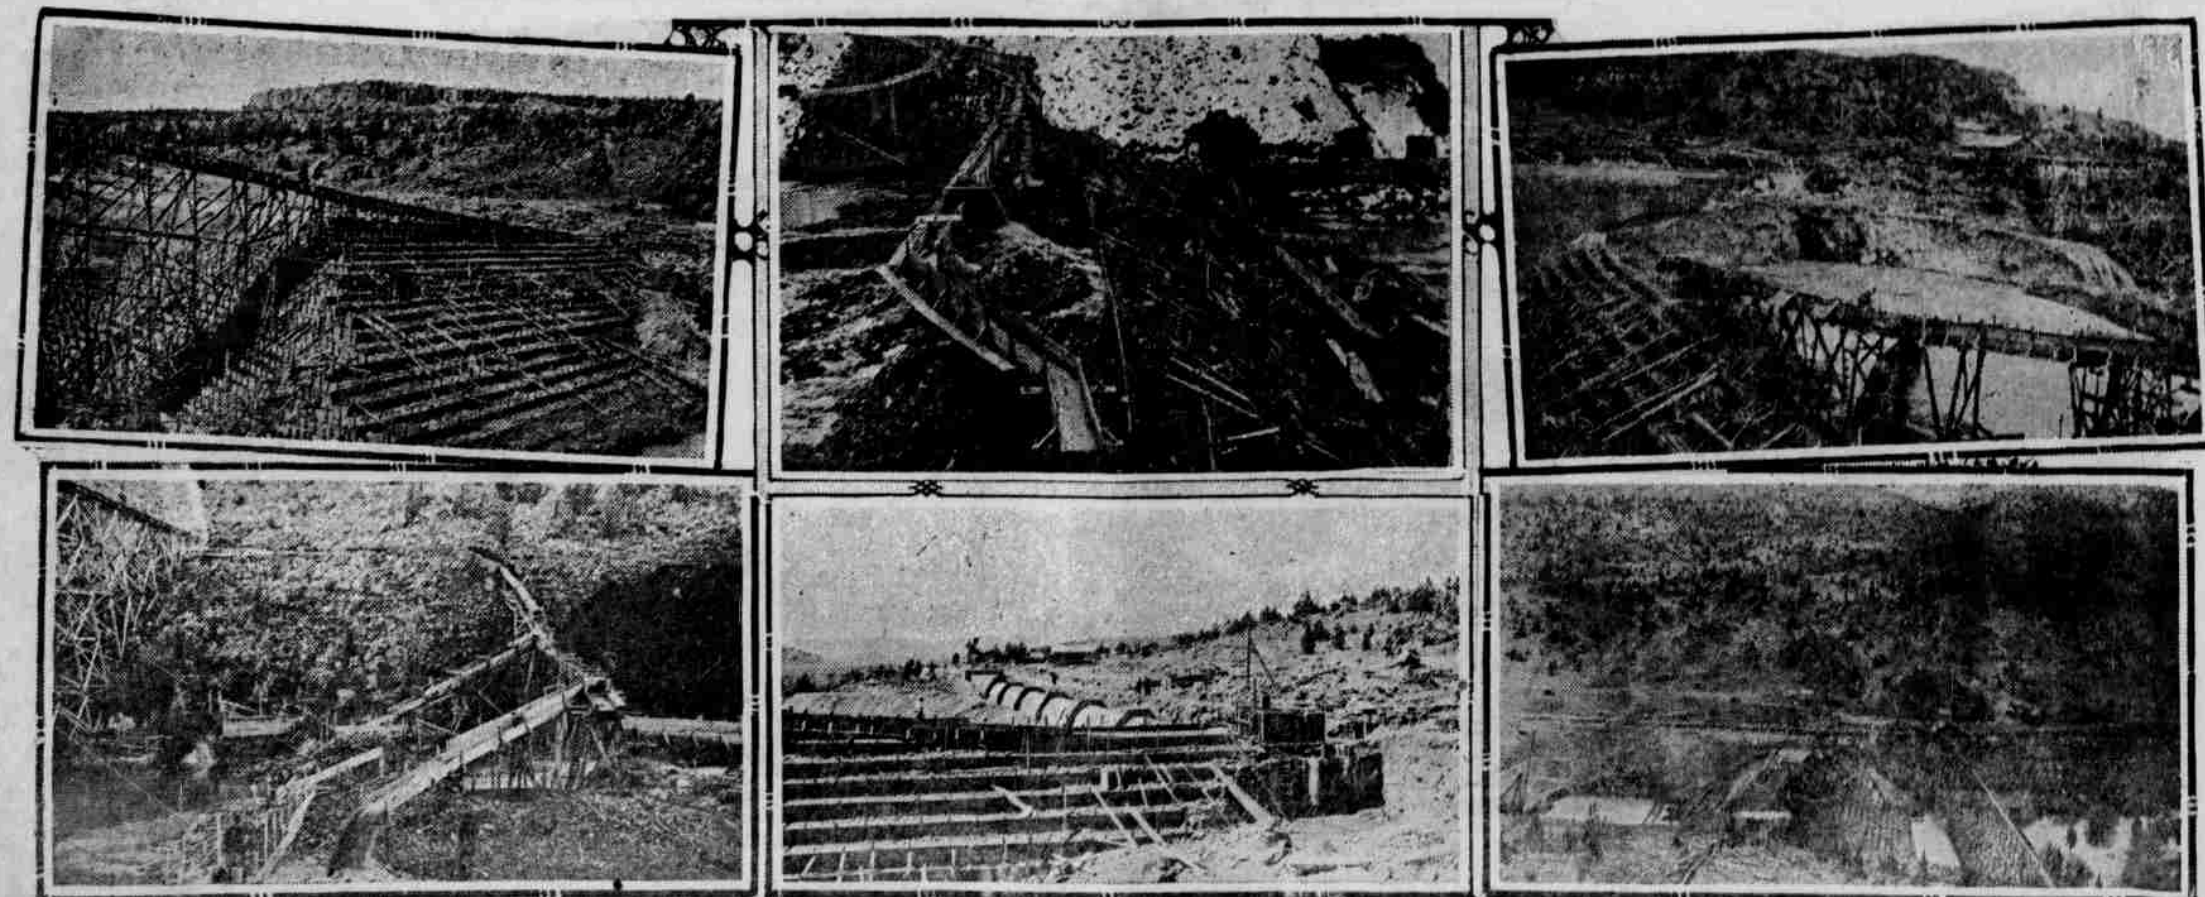
The group of pictures below shows the small dam in its various stages of construction and the method by which it was built.

The material is washed in through open flumes, and is held in place by the use of twelve-inch boards, held in position by stakes driven into the material as the height of the dam increases.
