## LIFEINTHEBIGHOUSE

## A HISTORIC BATHROOM AT MINIMAL EXPENSE

Choosing antique fixtures from unlikely sources

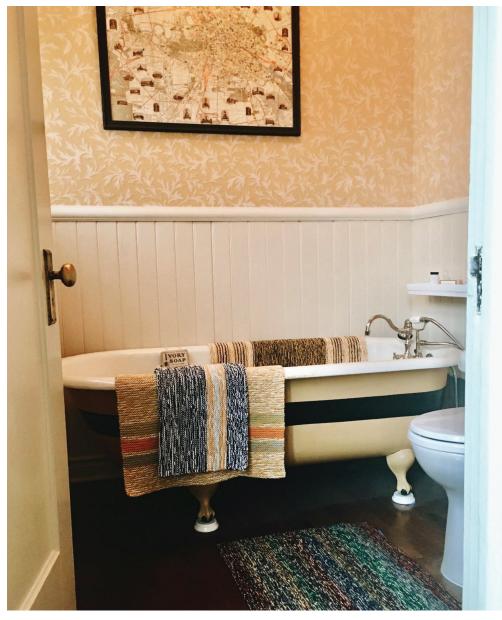
The finished bathroom with anaglypta wallpaper and polished nickel hardware.

Wallpaper is a great place to express creativity. I favor thick, embossed English wallpaper called anaglypta. I painted the base coat and then the relief, using a solution of two parts glaze and one part trim. Paint with a small, sharply tipped brush. Adding glaze thins the paint, causing it to appear more translucent while lengthening its drying time. This gives more time to work in the desired look.

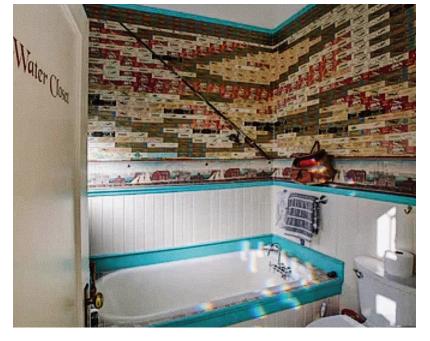
The bathroom in 2015.
The mosaic pattern of the wallpaper is made from vintage salmon can labels with a maritime border applied to cover fading and water damage.
