‘It looked like a river’

Burst water main sees swift repair

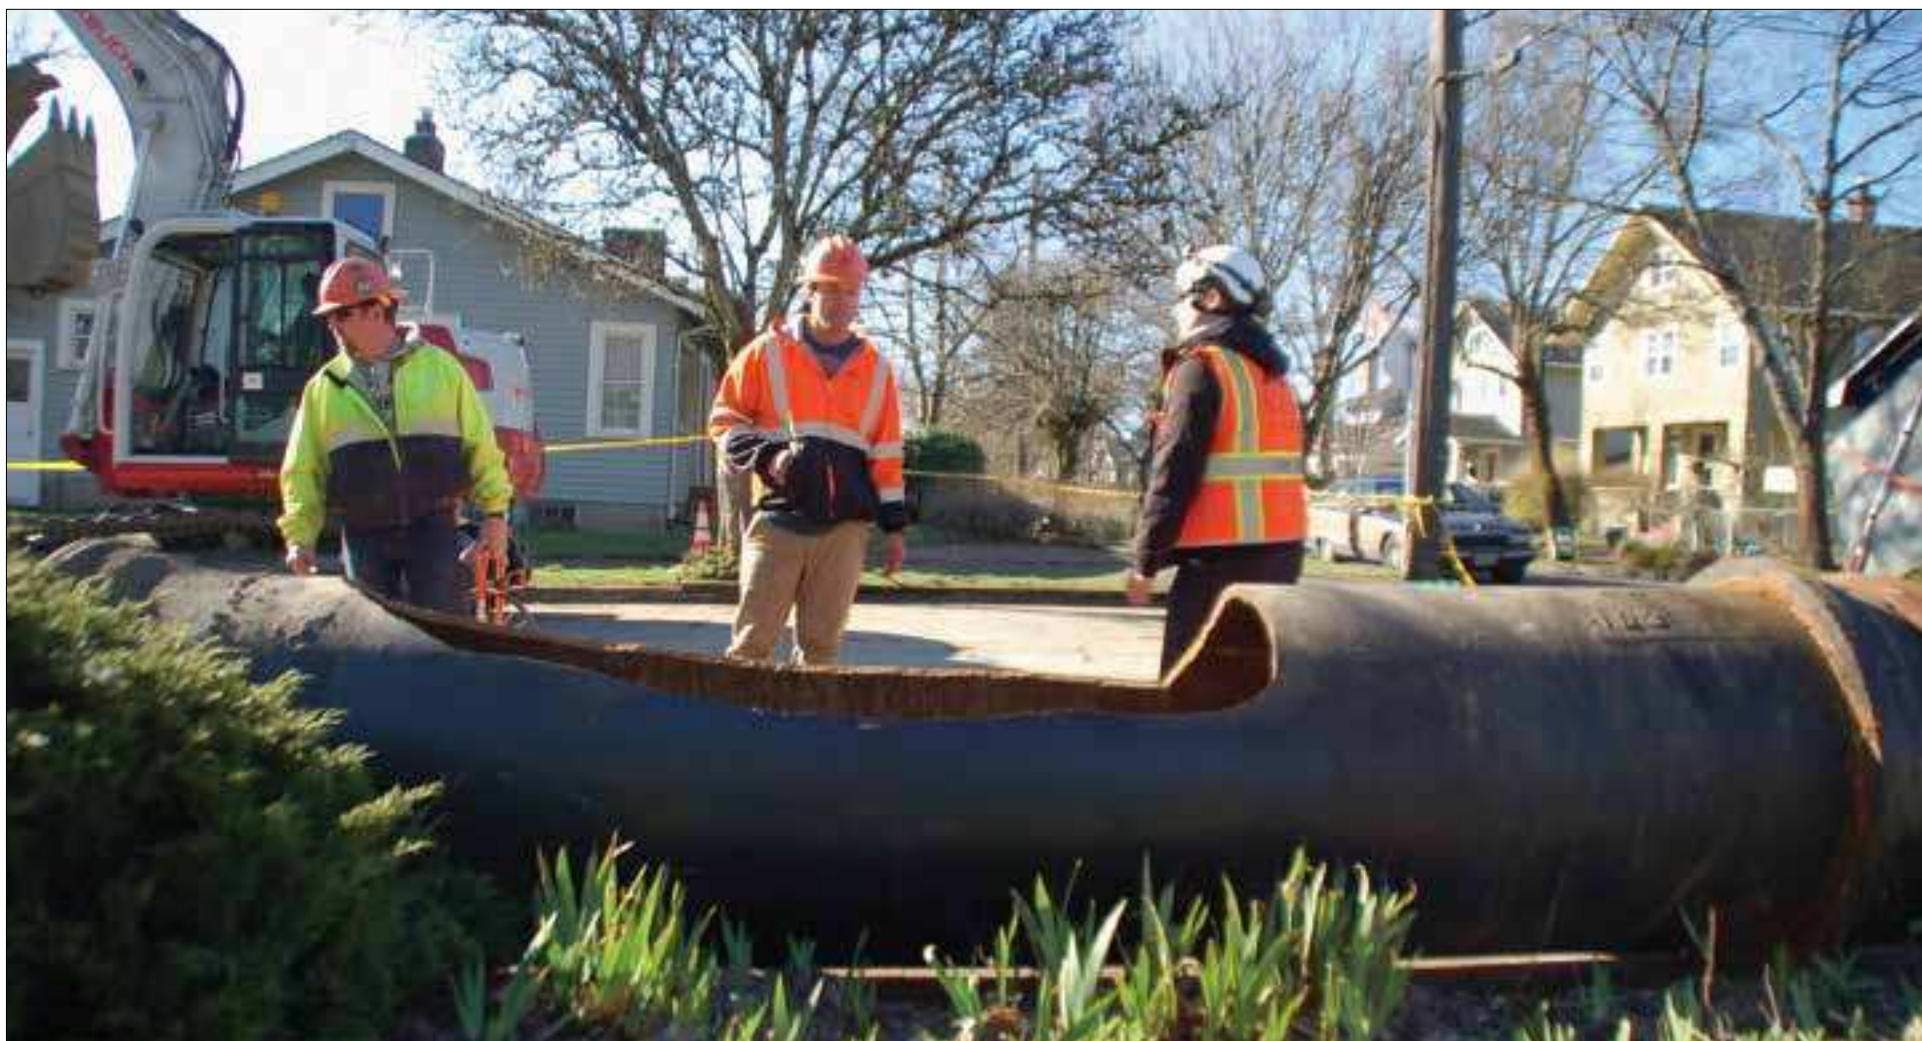
Portland Water Bureau crews examine a broken 30-inch cast iron pipe on Northeast Skidmore Street Monday after making repairs. When the pipe burst beneath the street on Saturday between 23th and 24th Avenues it caused millions of gallons of water to flood several blocks of the residential neighborhood and the Alberta business district.

The catastrophic failure was to a section of 30-inch cast iron pipe dating to 1915, causing a gaping hole in the line which was finally replaced by city workers on Monday near the corner of Northeast Skidmore

Andersen said there’s not a determination yet as to the cause of the break. The age of the pipe along with the added pressure on pipes from the thawing of frozen ground by warming temperatures and the

impacts from new construction in the area, are the top hypotheses.

The repair was the culmination of what amounted to a day and a half of around the clock work from Portland Water Bureau crew, Andersen said.

By late Saturday afternoon, PWB successfully reduced the water flow enough to start making repairs. From 10 p.m. Sunday night to 7 a.m. Monday morning, they successfully replaced the faulty pipe.
