## Sediment pollution site evaluated

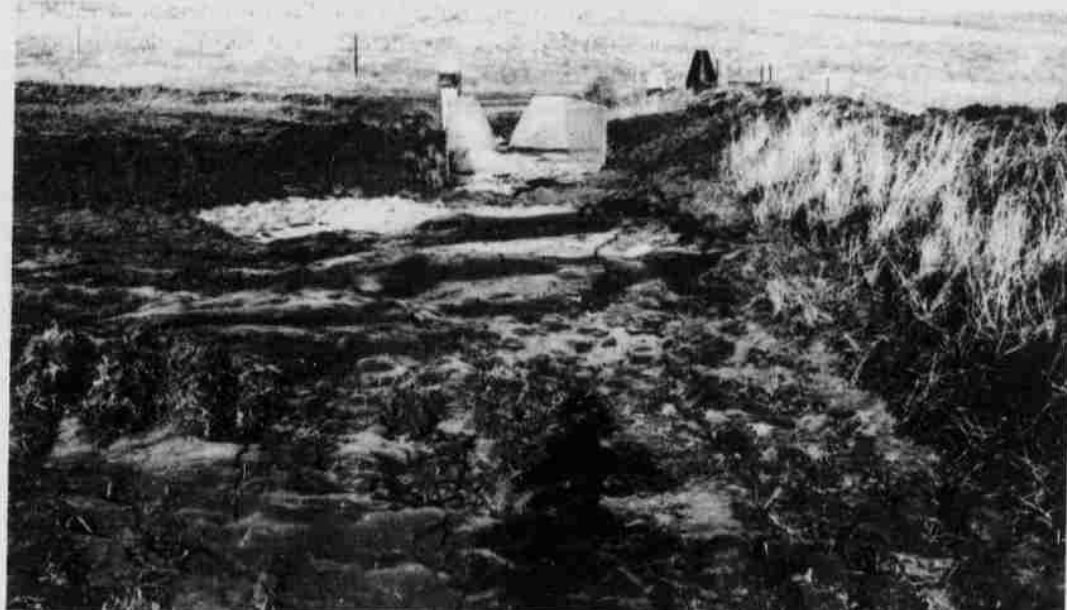
To provide the actual volume of water coming from a watershed, a flume is placed in a terrace channel. A stage recorder is used in conjunction with the flume to provide a self-recording document of the flow.

In October 1979 Gerald O. George, agricultural engineer, erosion specialist, Columbia Basin Agricultural Research Center, Pendleton, established a terrace evaluation and demonstration monitoring site on Don Peterson's ranch at Valby. The site consisted of a recording thermometer, a measuring flume and depth recorder. The rain and snow gauge was to determine hourly rainfall and snowfall intensity. The volume rain gauge was to determine total weekly precipitation and backup for the recording gauge. The thermometer was to determine the zero, three- and six-inch soil temperatures. The flume and depth recorder were to determine the amount of runoff out of the terrace.

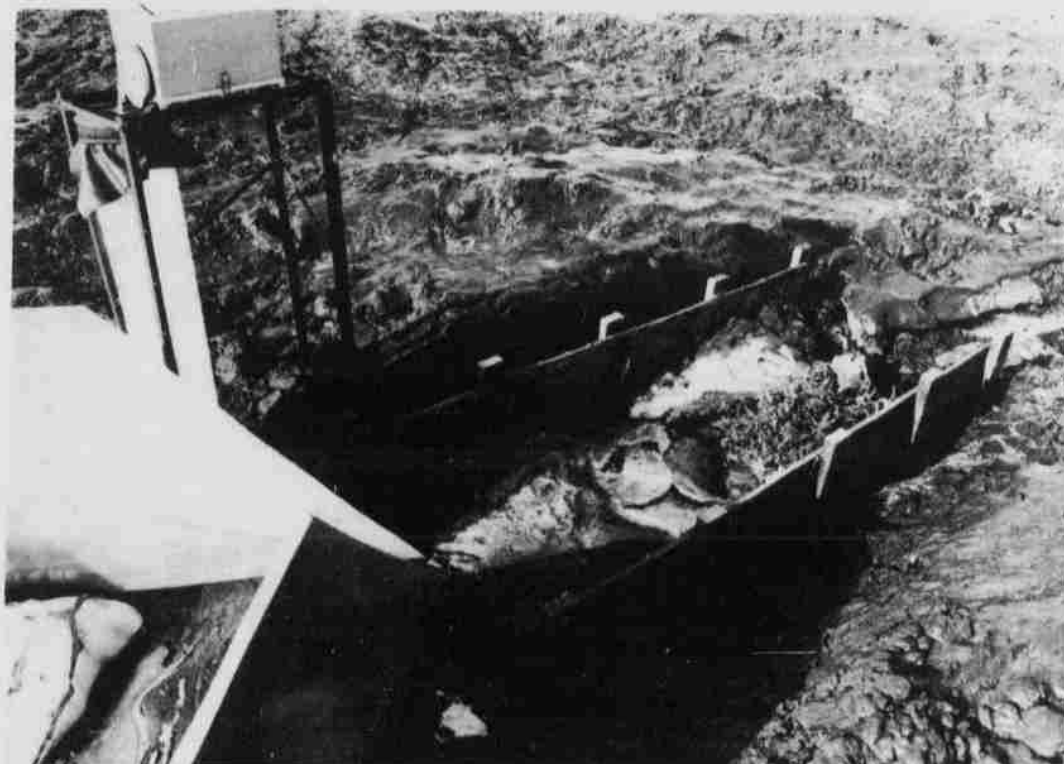
A sediment trap located immediately below the flume provides information on the amount of soil loss which is occurring in the same watershed. In addition samples are taken with a special meter to measure how much sediment is carried out with the water.

The average soil movement between terraces was measured to 12.5 tons per acre last year on this site. Approximately 20 percent of the soil movement was transported out through the flume and terrace outlet.
