WEEKEND Photorial

SUMP

TULE LAKE was once a watered basin, receiving the flow of Lost river. It was a lake without an outlet.

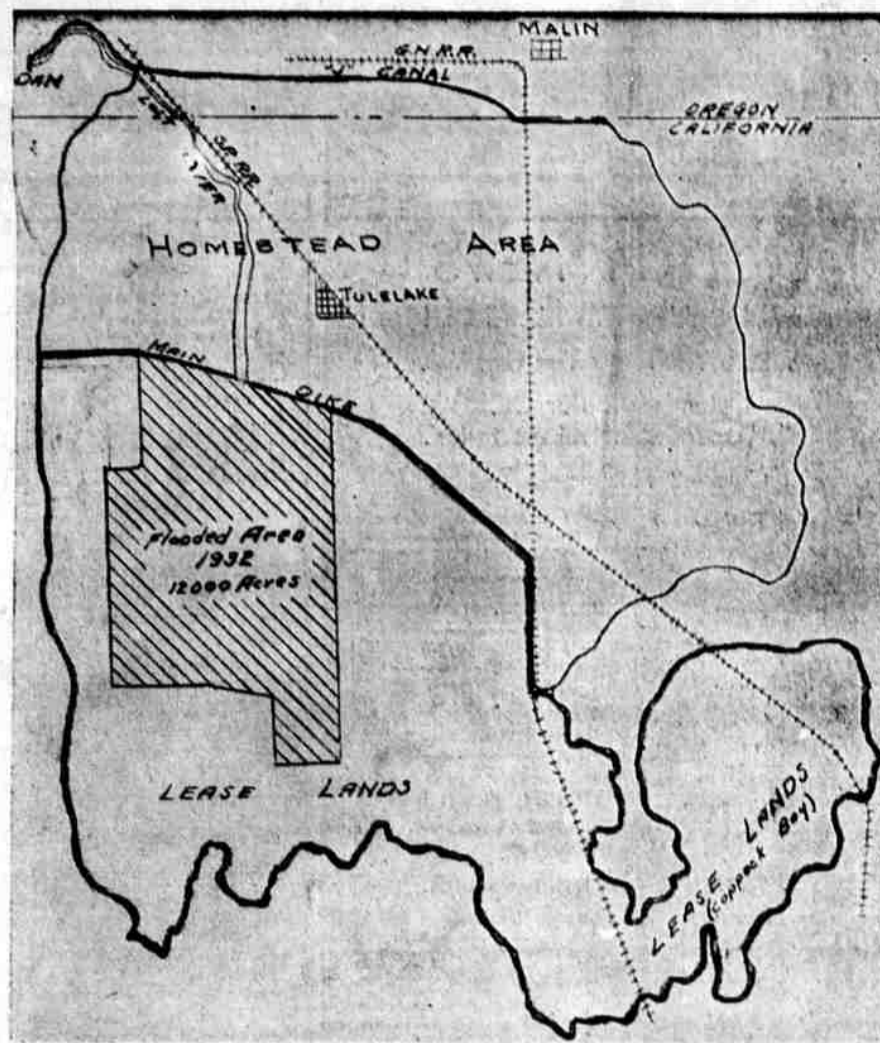
1932—This map shows the Tule lake basin as it was in 1932, when the flooded area was at its lowest point, and the other land within the sump area was at its maximum of cultivation. For years returns from this cultivated land have contributed substantially to the agricultural income of the Klamath basin, and fees from the leases have accrued to the credit of the Tule lake division of the Klamath project. As a wet cycle has come in recent years, sump lands have been re-taken by the water, with consequent losses in revenue both from farming and fees. The total of these potential losses is conservatively estimated in excess of \$750,000. What has happened to the land within the sump area is shown in the adjoining map.

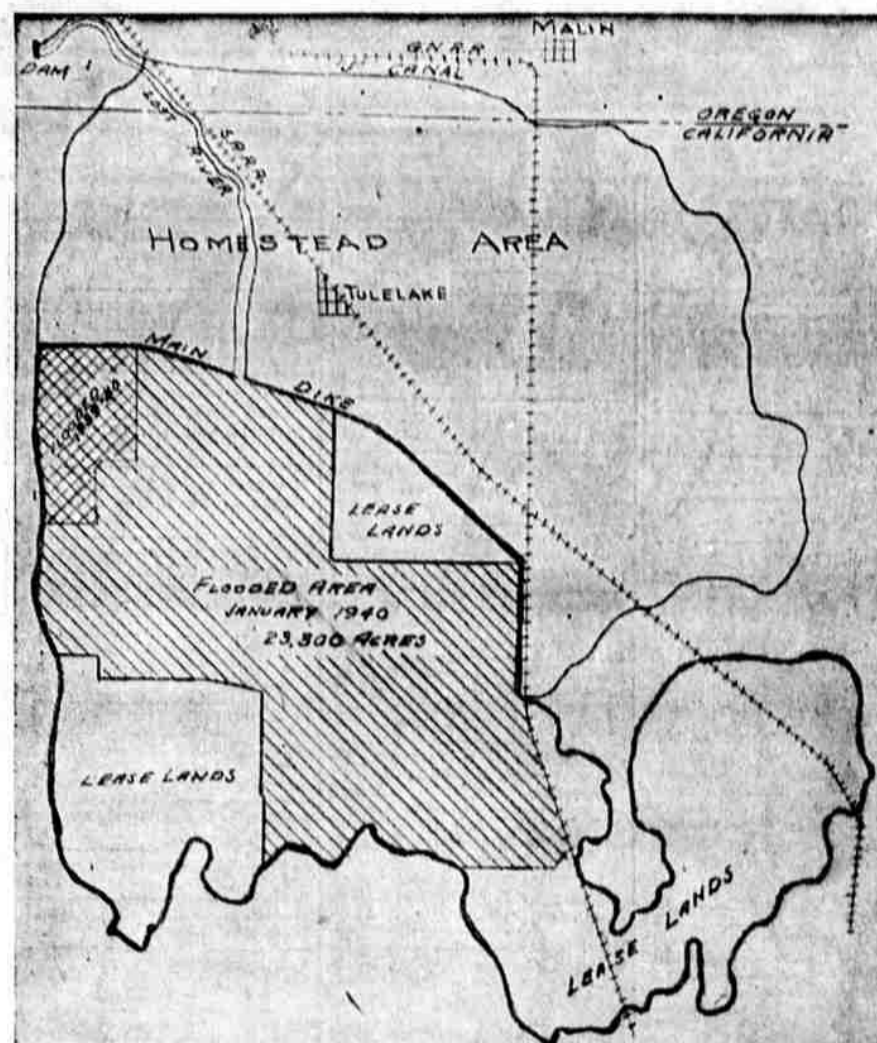
1940—How the water has spread over the land is plainly illustrated in the shaded area on this map, which should be carefully compared with the map on its left. Since 1932, the year of conditions pictured in the first map, approximately 12,000 acres within the sump area at the upper left hand corner of the map, has gone into private hands. Note that in 1940 the newly flooded area (cross-hatched on the above map) includes this privately-owned land as well as some land that is currently leased. Thus the encroachment by the water is still going on, and today it is feared that another 2500 acres must soon be flooded within the sump area, while there is concern lest excessively wet years will endanger the privately owned homestead lands above the main dike.

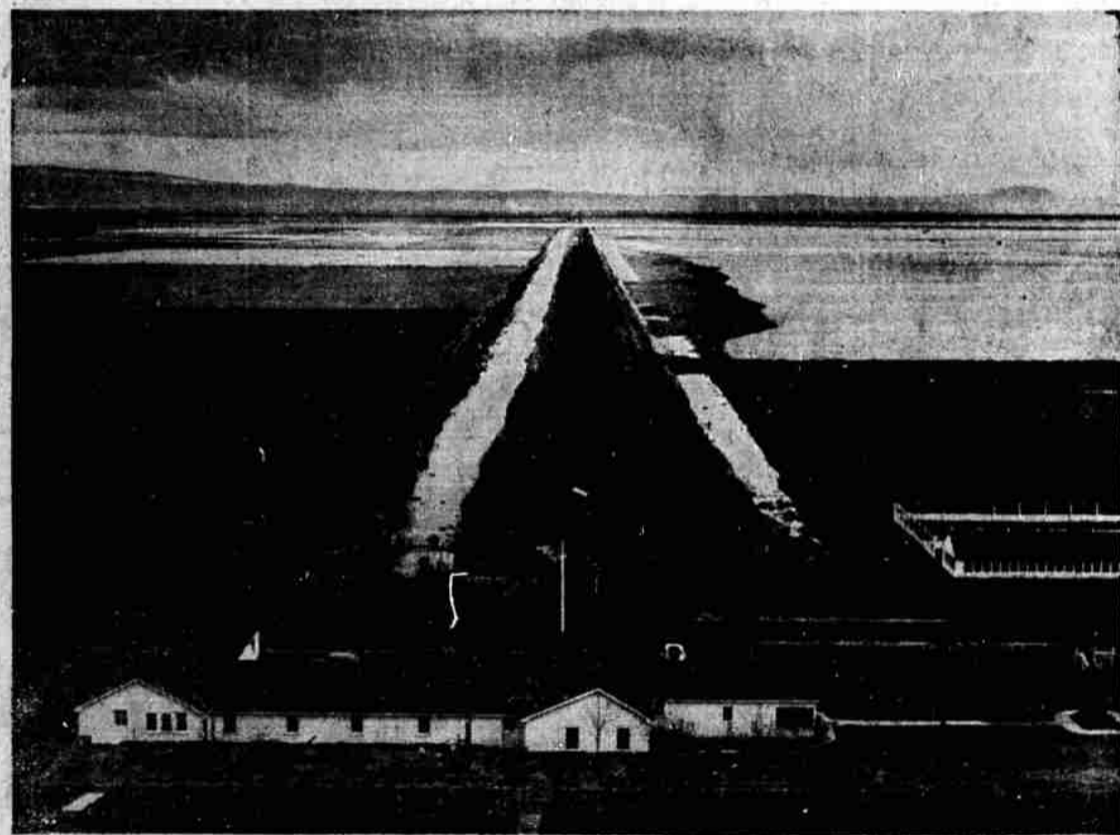
DANGER POINT—This is a view of the main reclamation service dike, with the biological survey headquarters in the immediate foreground. To the right of the dike is newly flooded land, showing the water approaching the main structure which protects the homestead lands of Tule lake. Here is danger, for the water is open and subject to wind action, and the dike, although a rugged structure, is dry and new in this section to the job of holding off the pressure of the flood.

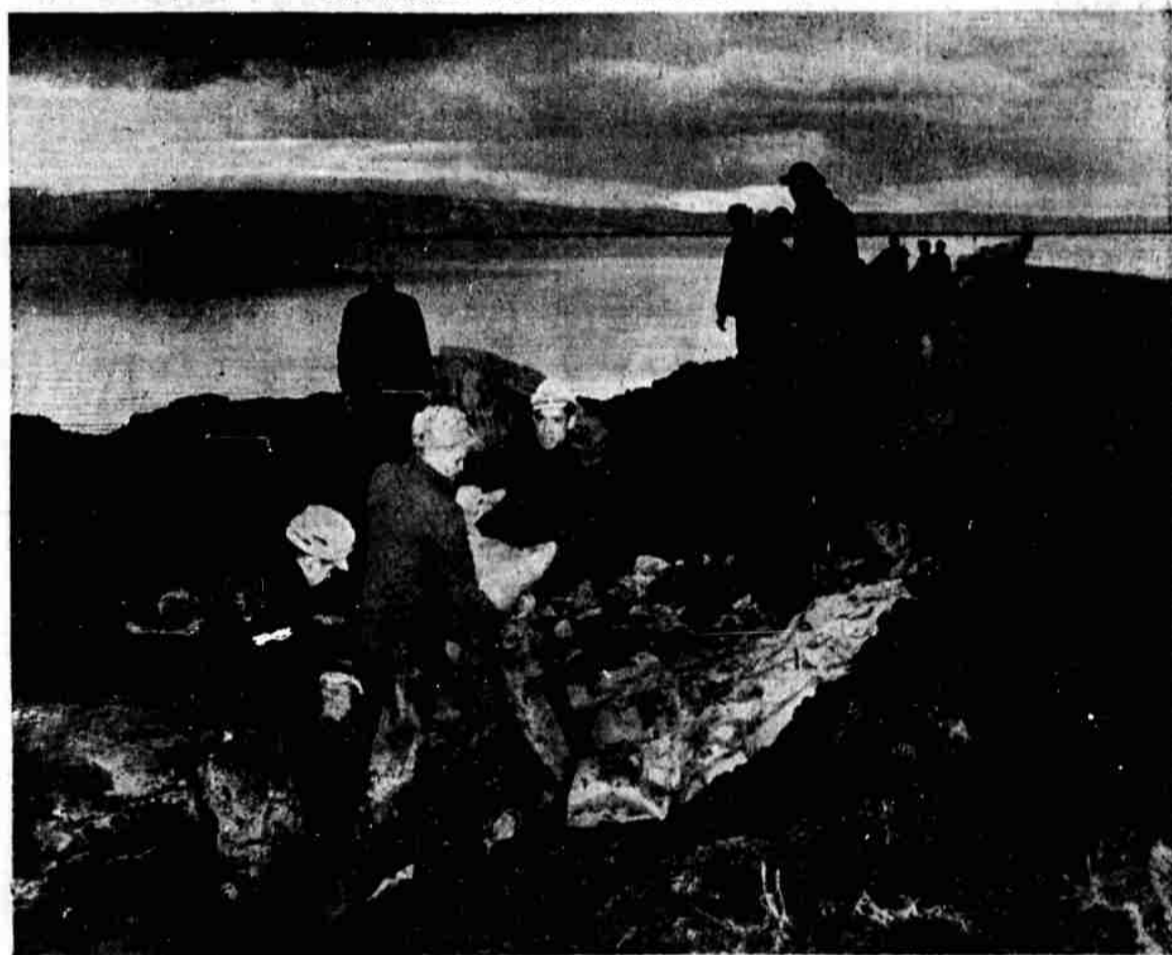
ATTACK AND DEFENSE—CCC boys from Tulelake camp strengthening a dike. The open water seen in the picture is highly dangerous to such protective structures, for there is nothing to break the wind and wave action.

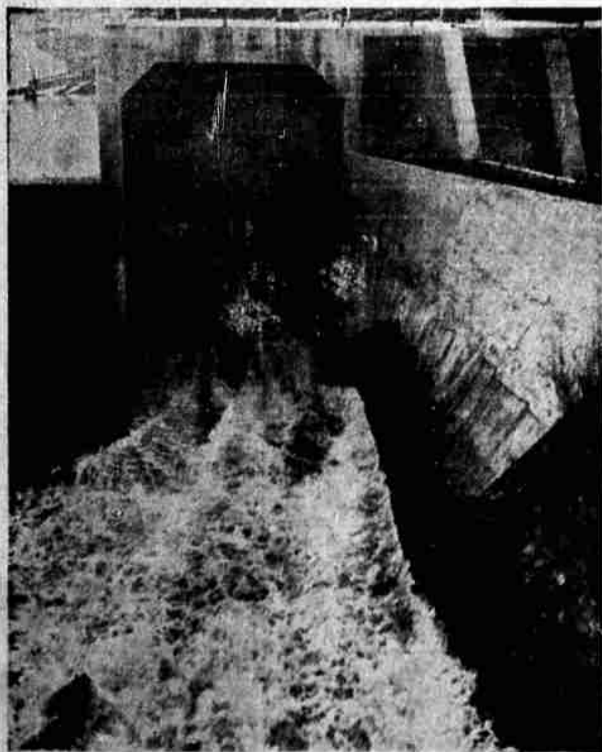
ON ITS WAY—This picture shows water gushing through the sluice gates on the Lower Lost river diversion dam at the old stone bridge. This water is on its way to the Tule lake sump.

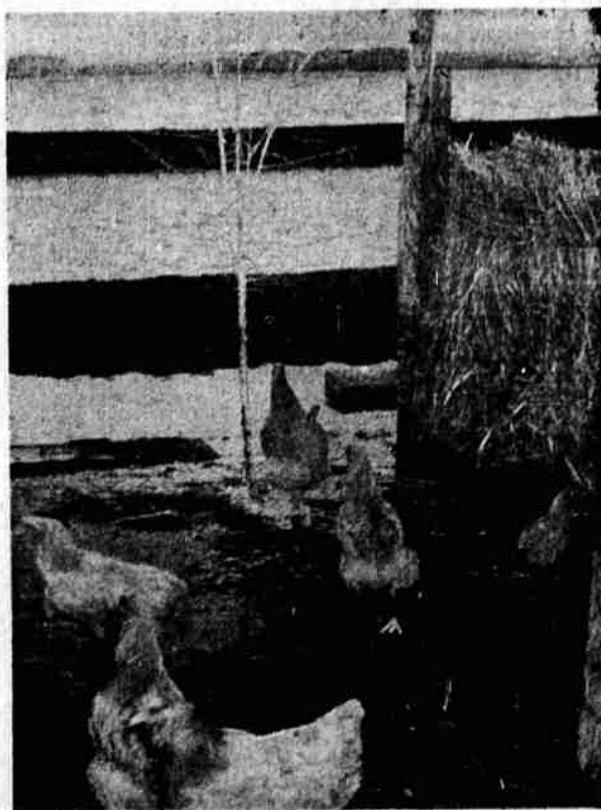
INVASION—River, stay 'way from my door. Flood waters are here encroaching upon a chicken yard at the headquarters of the Steele Land and Livestock company on the west side of Tule lake. The company moved out its permanent buildings to save them from the flood. The chicken yard was within a few feet of the house.
