Bridge on Pebble Creek Road gets new pilings in unusual repair

Columbia County Road Department recently called in the experts at the Linn County Road Department to help with repairs to state bridge 13681A, known locally as the Pebble Creek Road bridge in Vernonia.

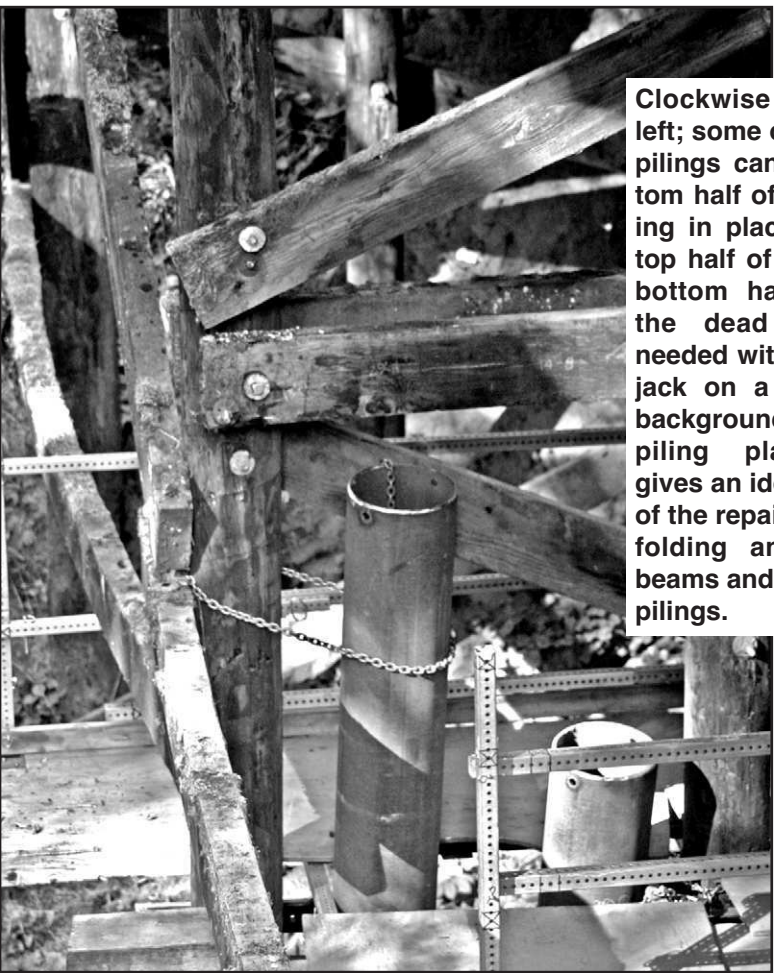
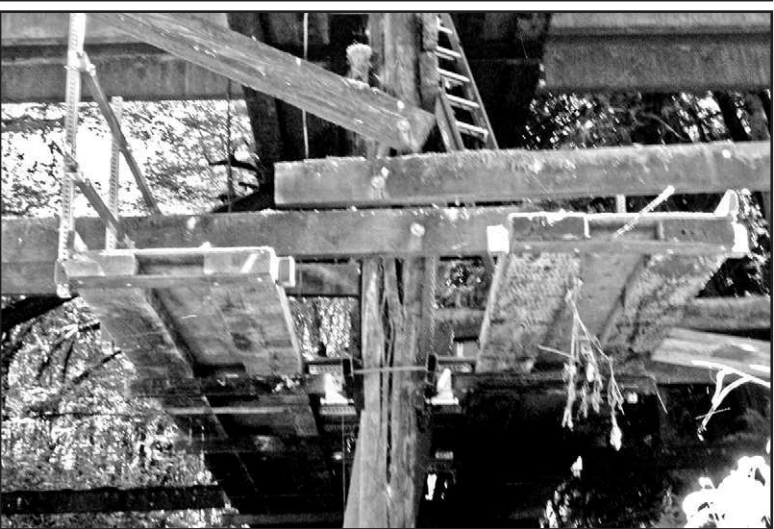
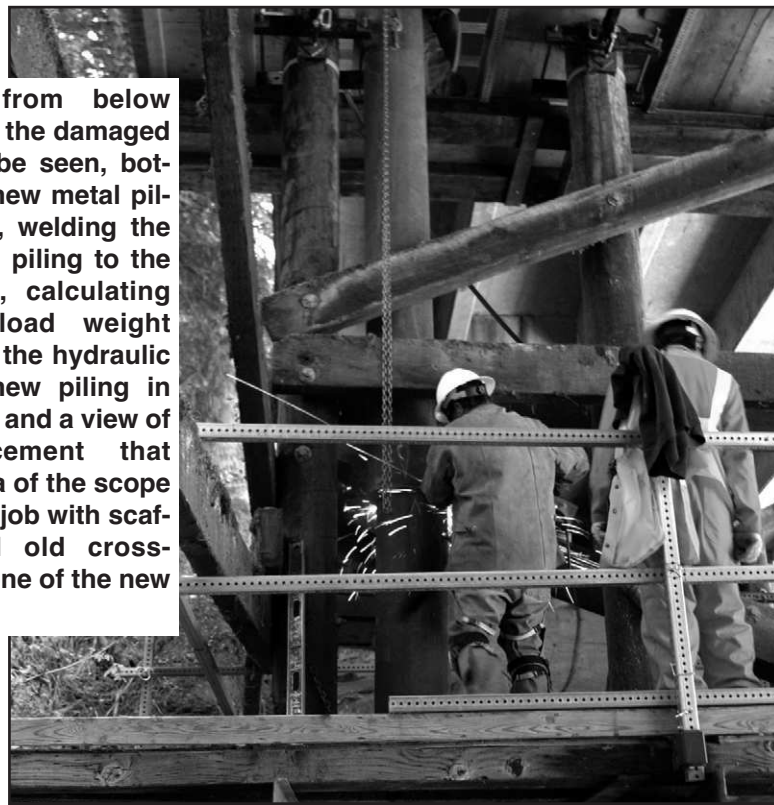
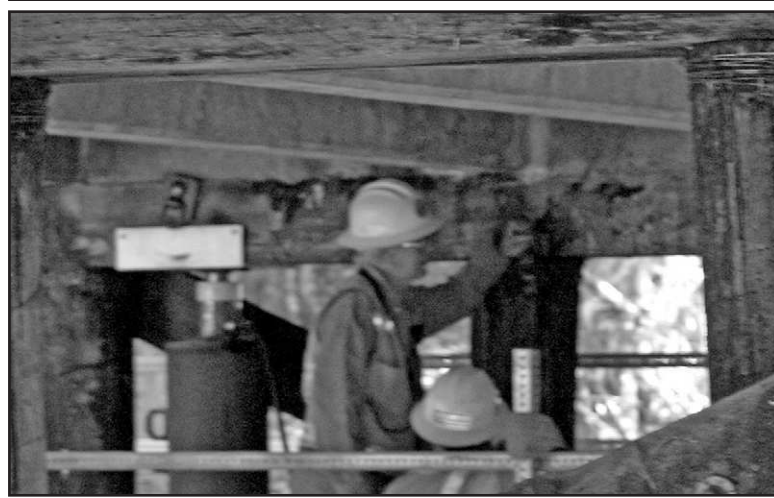
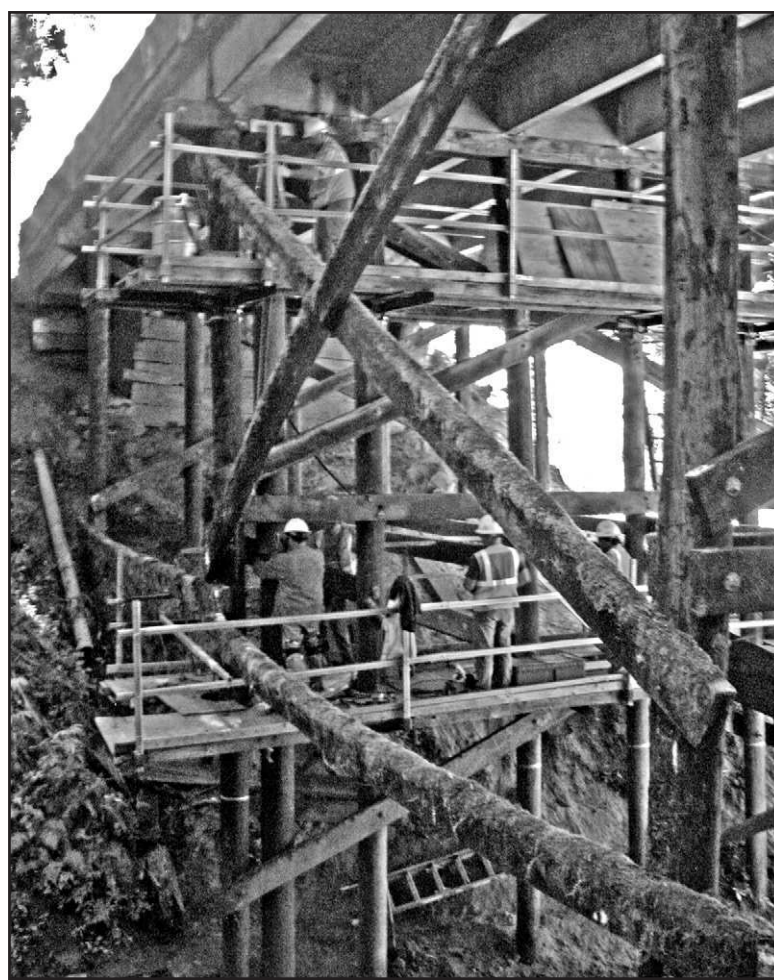
Clockwise from below left; some of the damaged pilings can be seen, bottom half of new metal piling in place, welding the top half of a piling to the bottom half, calculating the dead load weight needed with the hydraulic jack on a new piling in background, and a view of piling placement that gives an idea of the scope of the repair job with scaffolding and old cross-beams and one of the new pilings.

The bridge has been weight restricted for some time, since the county found that traffic on the bridge had caused some of the supports to bow out, indicating a weakening of the bridge.

The crew augmented the exterior side wooden pilings on both sides of the bridge farthest from Vernonia. Using a two piece metal piling with an inner lining, they place the two pieces of piling, weld them together, then place a 55-ton hydraulic jack on top. After calculating the dead load weight of the bridge (with no vehicles on it) they determine the weight needed on top to allow them to jack the piling into the ground without lifting the bridge. The goal is to drive the piling into the ground anywhere from three to 13 feet deep, to anchor the new piling, while keeping the top at the right level for the bridge to rest upon it.

Some of the challenges are to get scaffolding with railings into place, putting the new piling (larger diameter than the old wooden ones) into place without creating more problems, figuring out how much weight to put on the bridge to keep the bridge from lifting while they drive the piling, then not knowing how deep they'll be able to drive it.
