Washouts, Bottlenecks Slow Race Flow

MAP OF MILLRACE: BEGINNING TO END

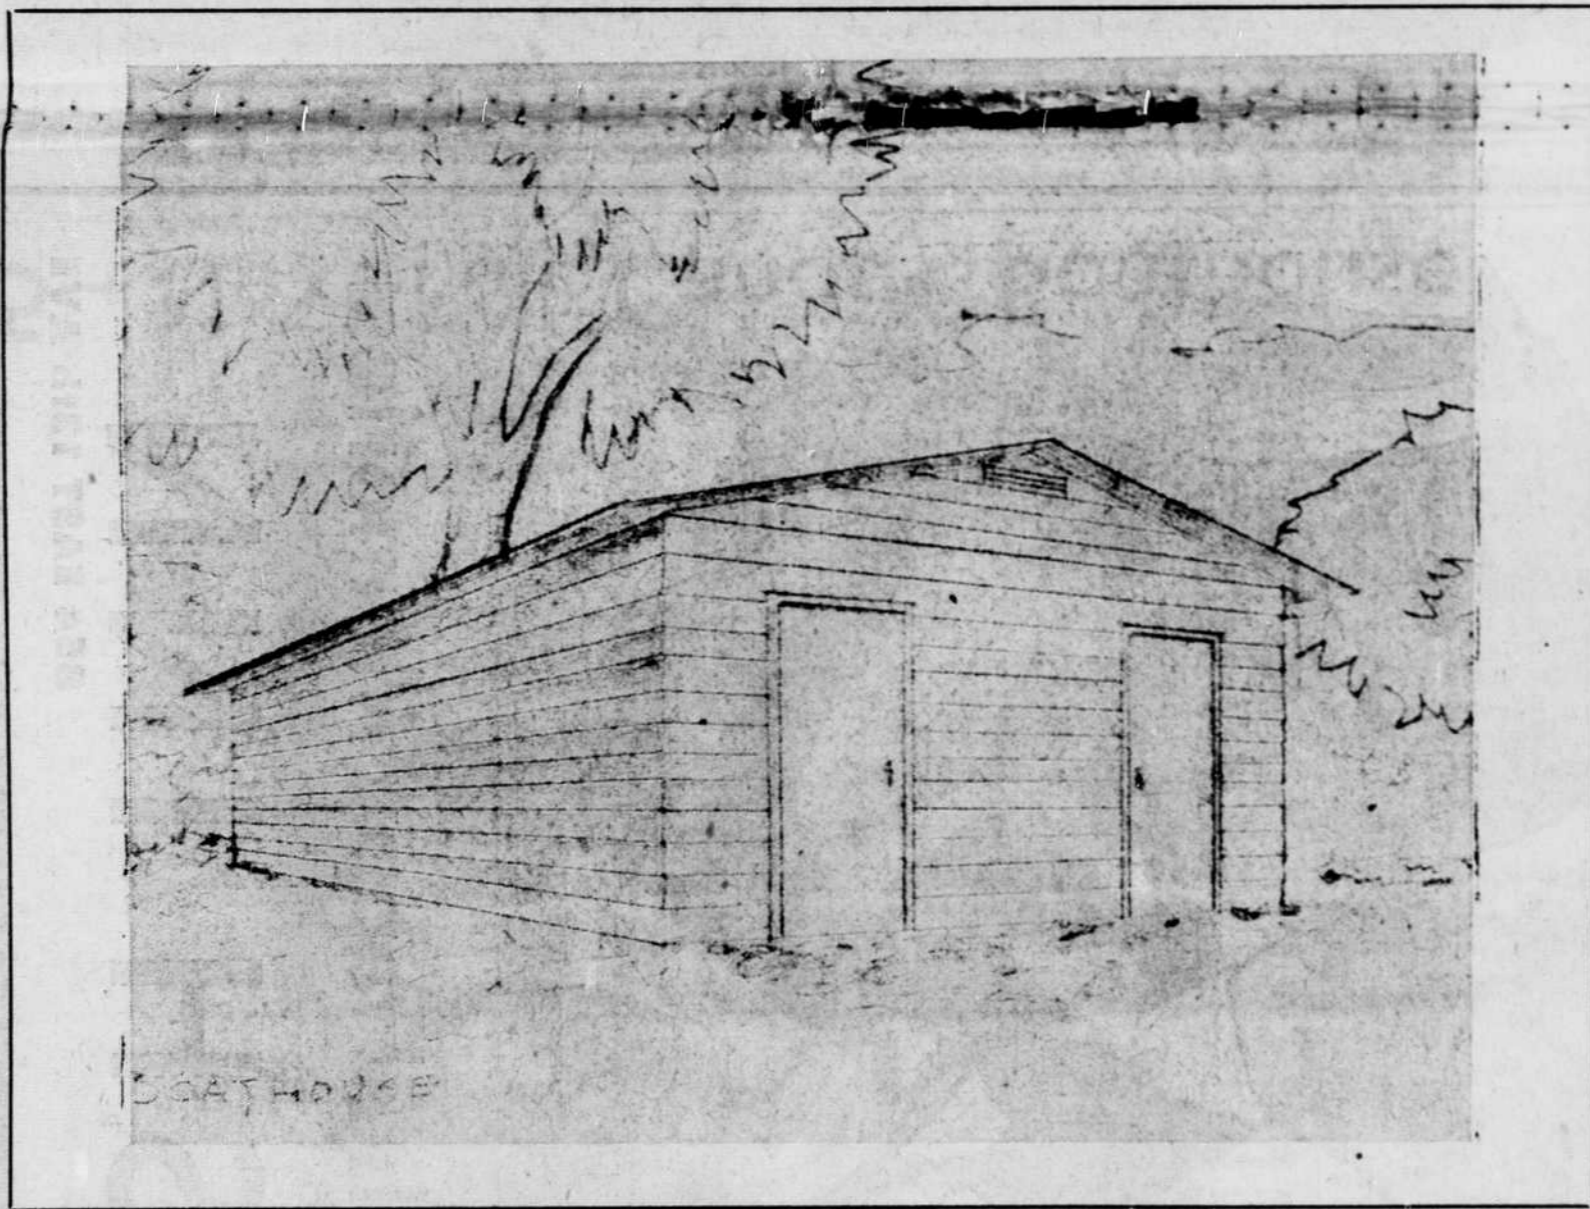
5 – Next Fall: Canoes, Boathouse

ROOM FOR ABOUT 20 CANOES will be provided in this boathouse, which is planned for a site east of the physical plant. Subject only to the approval of the budget board, it will be operating with canoes by fall term. The Student Union will operate the

canoe rentals. This is just one facility of a larger project "The Anchorage," which is planned for the future. The larger unit will include dining, dancing and other recreation facilities.
