# Emigrant Dam Is Constructed on Scientific Principals

## Material Is Not Loose Dirt, Rock, Engineers Report

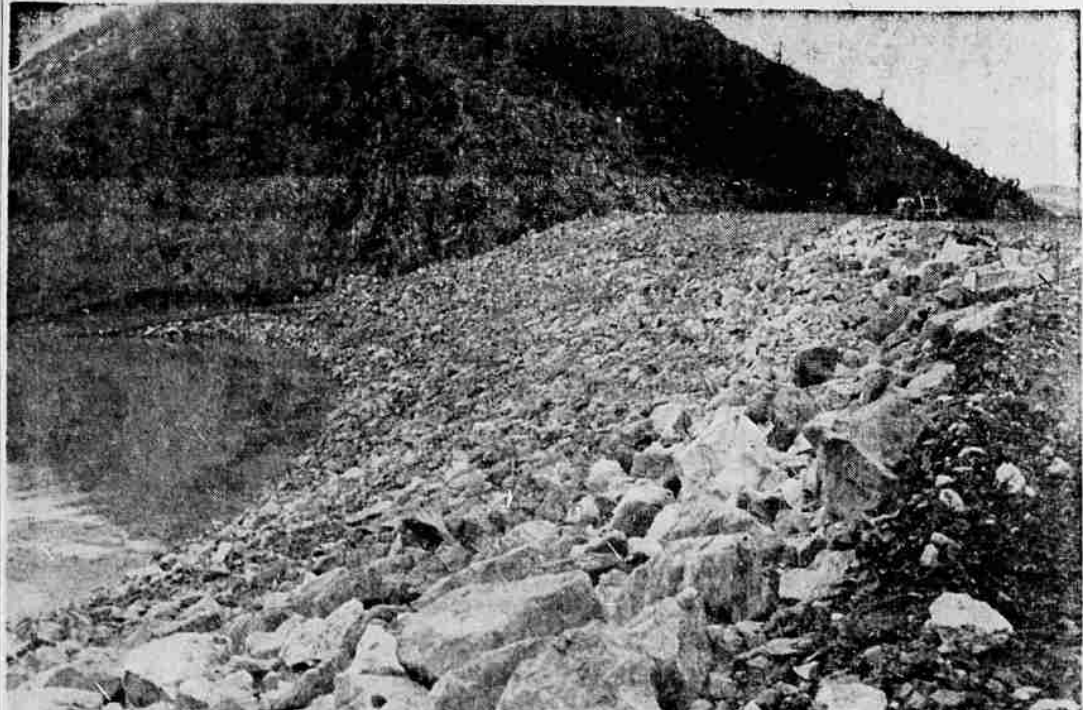
**SURFACE OF DAM** — The lake-side surface of Emigrant dam is shown above. It is covered with rocks and boulders. The level of the lake (at left) was several feet higher when this was taken than the height of the old concrete dam

natural rock abutment is shown in background. Base of dam is several hundred feet to the left beneath the ing water.
