### Move to safety

### A gentle approach

### Simple steps

### Importance of preservation

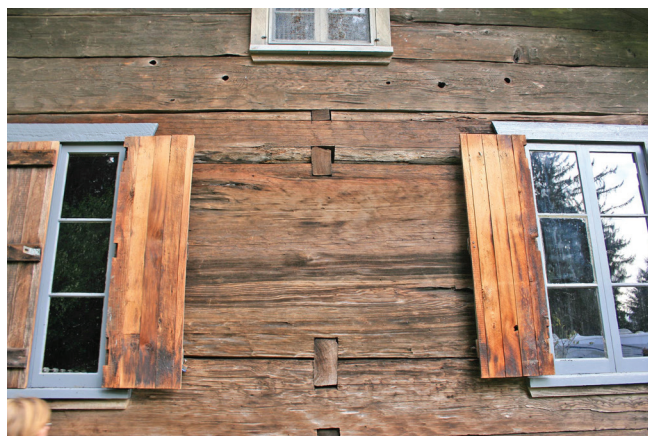
A single plank spans nearly the entire height of the windows.

Imagine the tree from which it came. Perhaps more amazing, the men did the work with only three hands; Merila lost the digits to one of his hands in a childhood accident.

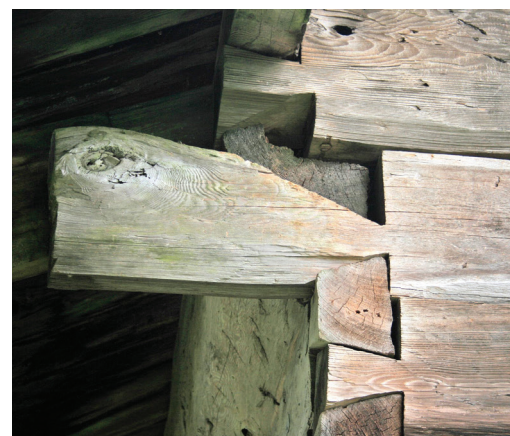
Lindgren added an artistic touch, extending the dovetail joint near the eaves.
