## Waning Water Woes

Irrigation and livestock water: two things which are absolutely essential to the livelihood of local farmers and ranchers; but four straight years of drought do not help the cause. The Baker County SWCDs, consisting of Baker Valley, Keating, Burnt River, and Eagle Valley, put a major focus on water developments and improved irrigation efficiency this year; helping landowners develop springs, install pipelines and watering troughs, as well as install diversion structures and head gates.

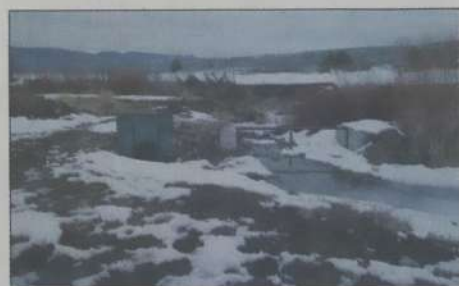
One sill/wing diversion structures on Camp Creek; Juniper bank stabilization.

material to aid in fish passage. To minimize stream bank erosion, 44 juniper skeletons were installed along the worst sections of cut banks. Along the same section, 26 willow clumps and 18 vertical bundles were planted to help reestablish woody vegetation. There was 5,000 feet of wildlife friendly fence installed to restrict livestock access to Camp Creek, thus protecting the newly stabilized riparian area.

In the Burnt River District, due to maintenance deficiencies, pushup style dams were previously in use on two of the main diversion structures to divert water from Camp Creek. Two other diversions were in critical shape, and did not allow for adequate fish passage. Camp Creek was also experiencing severe bank erosion and a reduction of stabilizing woody vegetation, therefore releasing sediment into the Camp Creek system. This large restoration project replaced four pushup dams with four concrete sill/wing-wall diversion structures. Head gates were also installed at each diversion, as well as streambed

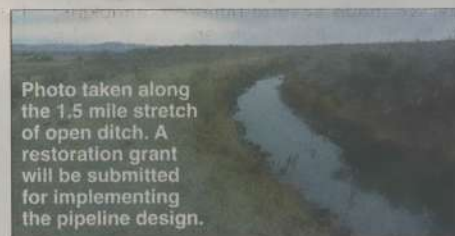
Photo taken along the 1.5 mile stretch of open ditch. A restoration grant will be submitted for implementing the pipeline design.

A Technical Assistance grant was recently completed in the Baker Valley District that also aims to improve irrigation efficiency and water delivery. The MaHarry-Blevins Ditch conveys water to the P-2 Pipeline, and is supplied by Wolf Creek Reservoir. About 1.5 miles of the ditch is open, and experiences considerable ditch loss by leaching through the banks, as well as through evaporation. After an Optimization Study was completed on the MaHarry-Blevins in 2013, it was determined that the ditch was losing up to six acre-feet per day, or 1,955,108 gallons of water per day! To account for ditch loss in the summer months, and to meet the irrigation needs of the producers, nearly twice as much water than needed must be released down the ditch. This project used grant funding to hire a licensed engineer to develop a 100% construction-ready design for installing a pipeline in the 1.5 miles of the open MaHarry-Blevins Ditch.

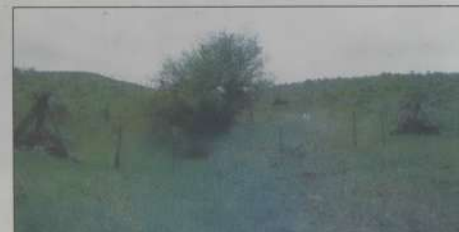
One of four developed and fenced springs; One of four rubber tire troughs for off stream livestock watering.

Upland restoration, although not tied directly, still plays a key role in water quality in Baker County. A large restoration project is just wrapping up in the Keating District, which focused on off stream watering and improved livestock distribution. A lack of a reliable water source can cause livestock to congregate in certain areas, typically overgrazing those areas and opening up niches for invasive species, like medusahead rye. Medusahead crowds and competes with native grasses and forbs, deteriorating forage for livestock, as well as habitat for wildlife such as Sage Grouse. This conservation project developed four springs on the property, and installed pipeline to convey water to four individual watering troughs. The newly developed springs were enclosed with wildlife friendly fence to aid in protecting the springs from trampling. A 4,500 foot cross fence was also installed as a part of this project, creating two separate pastures to aid in livestock distribution. These activities will greatly improve rangeland health and native species in the area, while allowing the landowner to better manage grazing on his private ground.
