## OUR ORDERS: "FIND THE THRESHER!"

Where is the graveyard of our lost nuclear sub and its 129 victims?  
Here, revealing deep-sea detective work never before attempted,  
is the stirring sequel to one of the worst disasters of 1963

By Capt. FRANK A. ANDREWS, U. S. N.  
as told to Jack Ryan

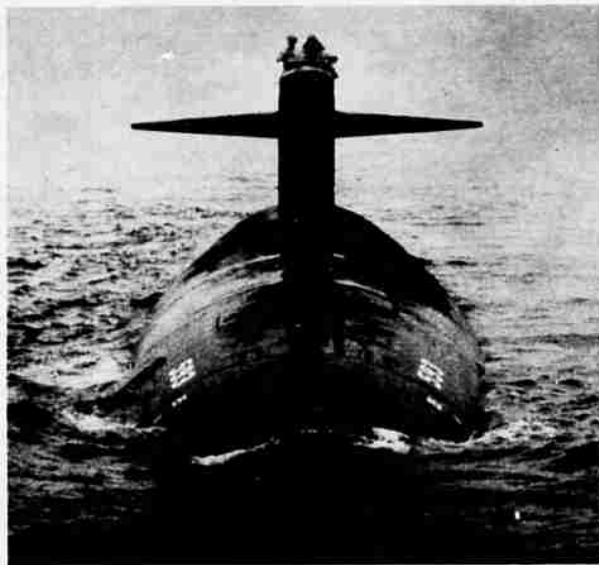
Direct bow view of the ill-fated *Thresher* before she was lost.

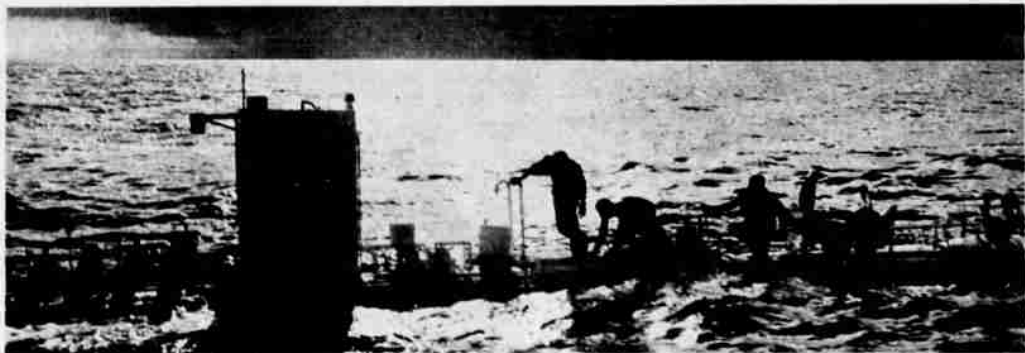
The bathyscaph dived 1½ miles to find the wreckage but was handicapped by limited range and visibility.

If their persistence had paid off, it would mean we could move closer to the ultimate search—sending down the Navy's bathyscaph *Trieste* with trained observers who could study the wreckage firsthand and take close-up photographs.
